TOWNSHIP BRIDGES

MILFORD TOWNSHIP
SCHOCOPEE ROAD

MOON VALLEY/DEEP BROOK ROAD
MILFORD TOWNSHIP
PIKE COUNTY, PA

ENGINEER'S REPORT:
Preliminary Inspection & Evaluation
of Township Bridges
with Maintenance Recommendations

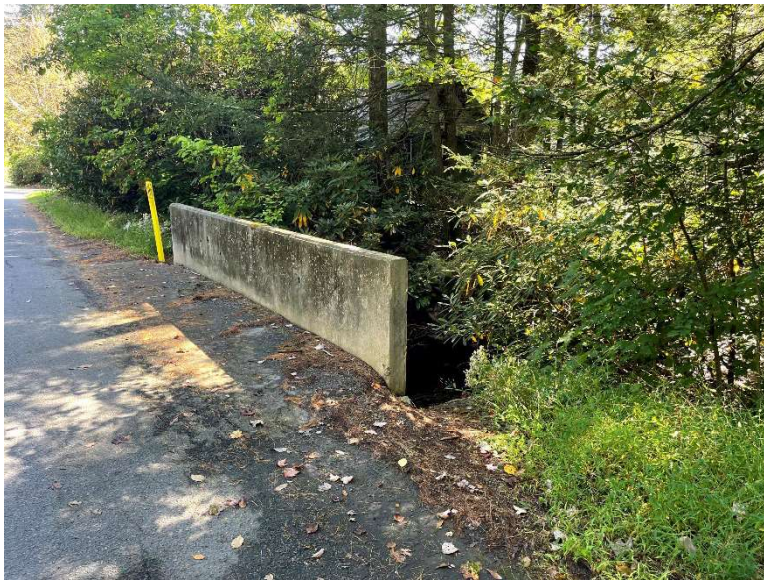
Protective Barrier

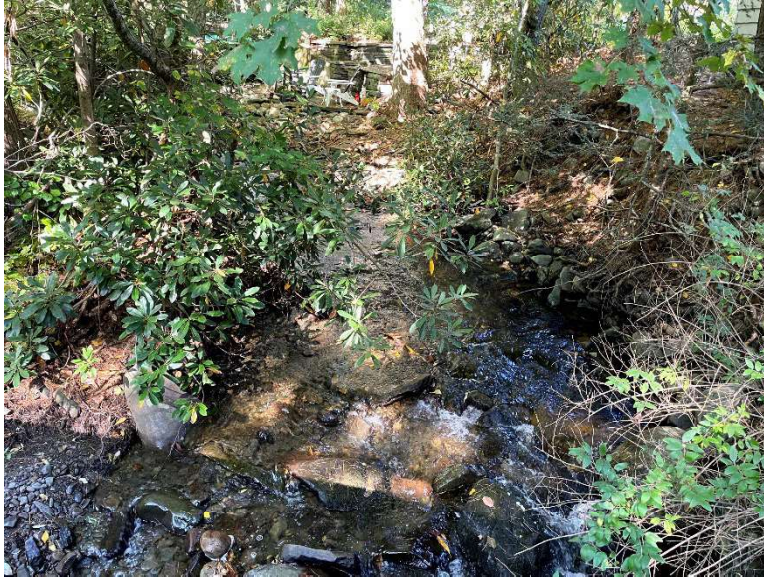
Downstream Side

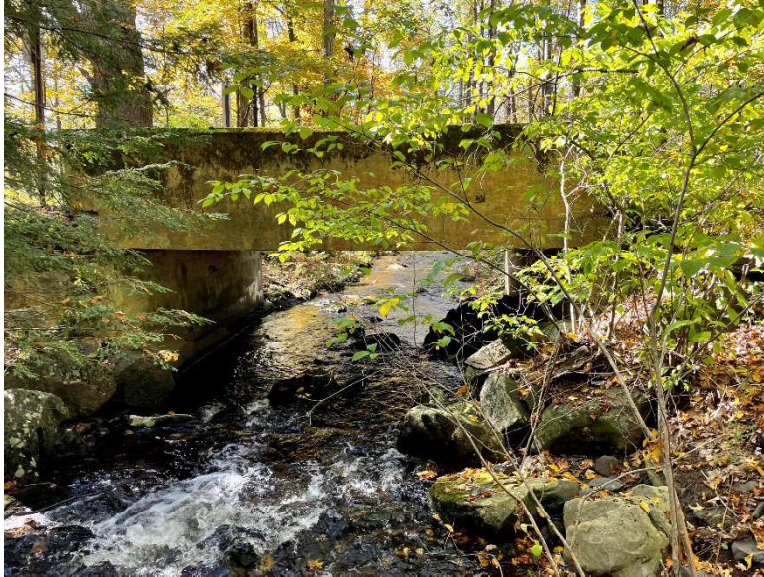
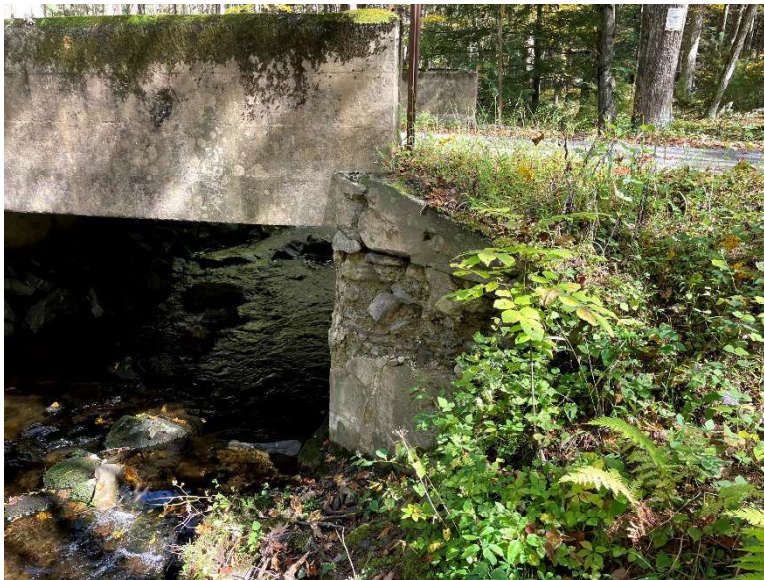
The abutments due show sign of wear. The abutments have some minor cracking with areas of significant spalling. There is no evidence of delamination, however, there is evidence of efflorescence which may lead to spalling in the future.

Abutment – Area of Significant Spalling

A long-term repair of spalling conditions on the bridge abutments should be scheduled and budgeted as part of the maintenance of this bridge. Similar to Bridge #1, this bridge shall have regular inspections to monitor its performance.

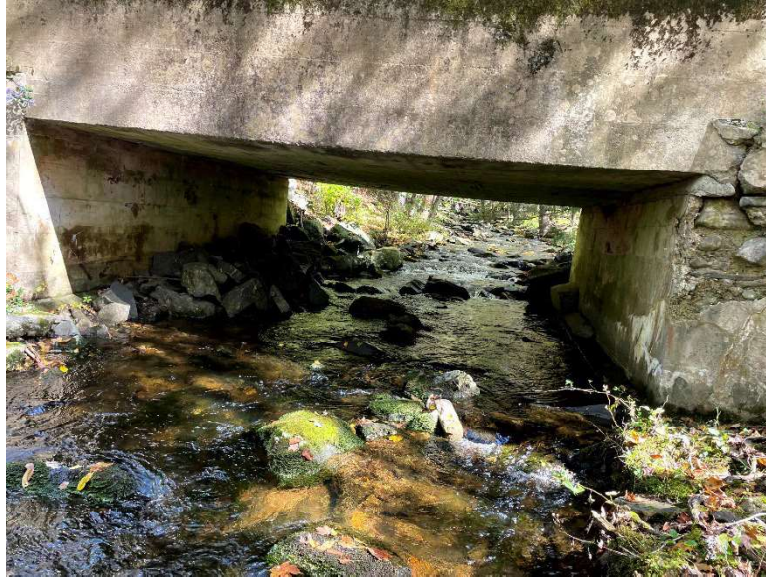
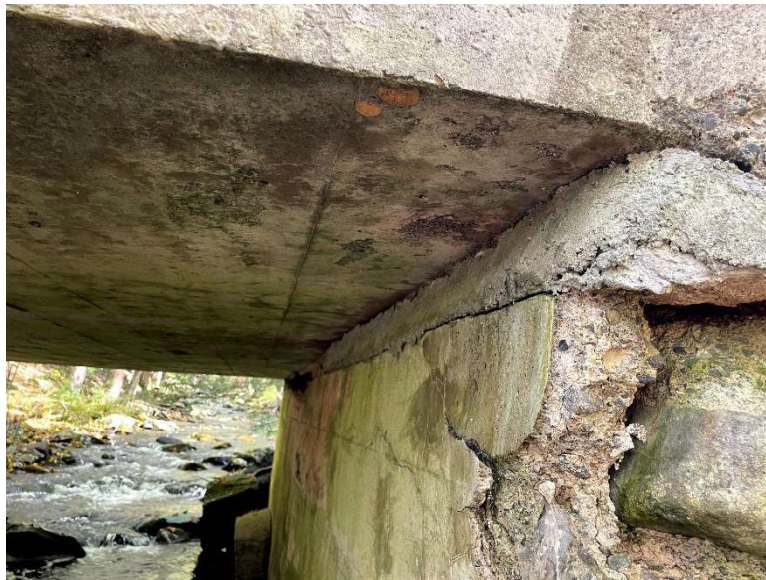
Significant Spalling

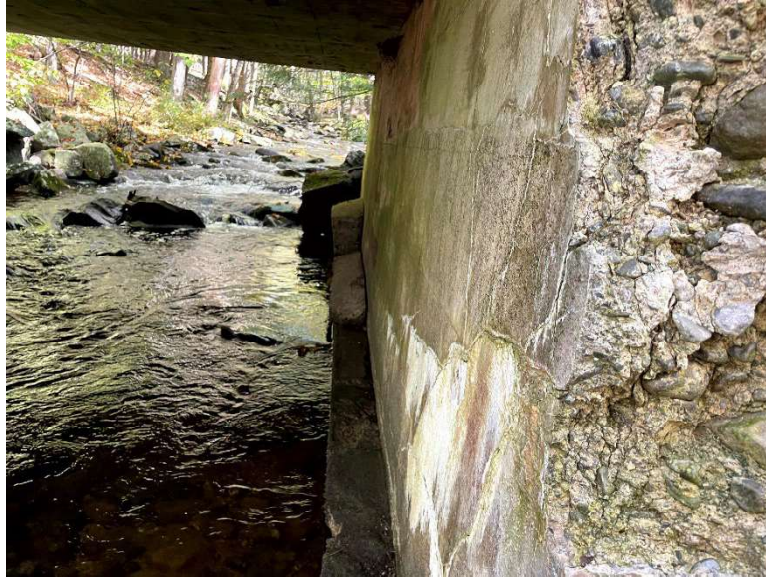
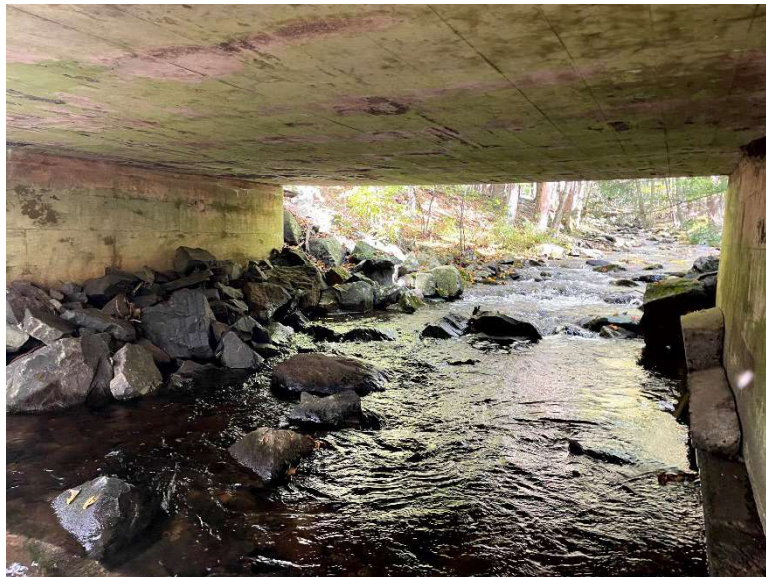
The bituminous pavement has no evidence of cracking in the longitudinal or transverse direction. There is no evidence of deflection. The concrete deck, which was inspected from the underside, has minimal cracking but no evidence of spalling.

Underside of Deck in Good Condition

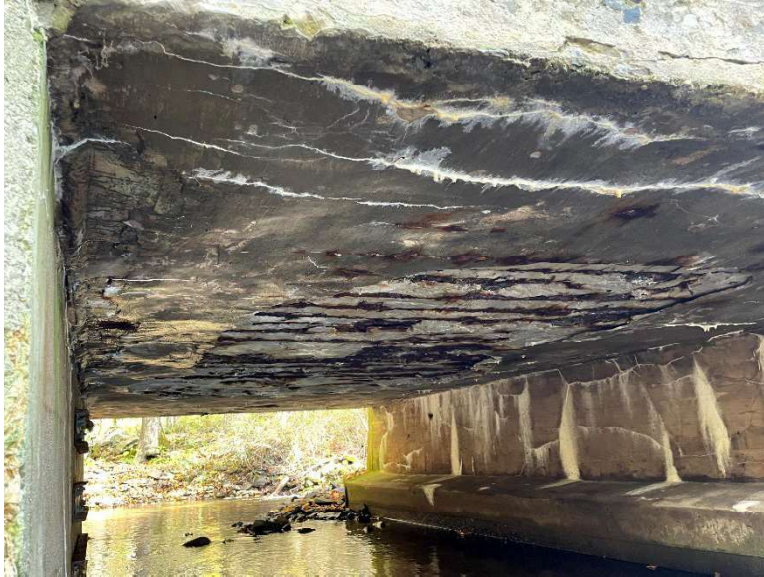
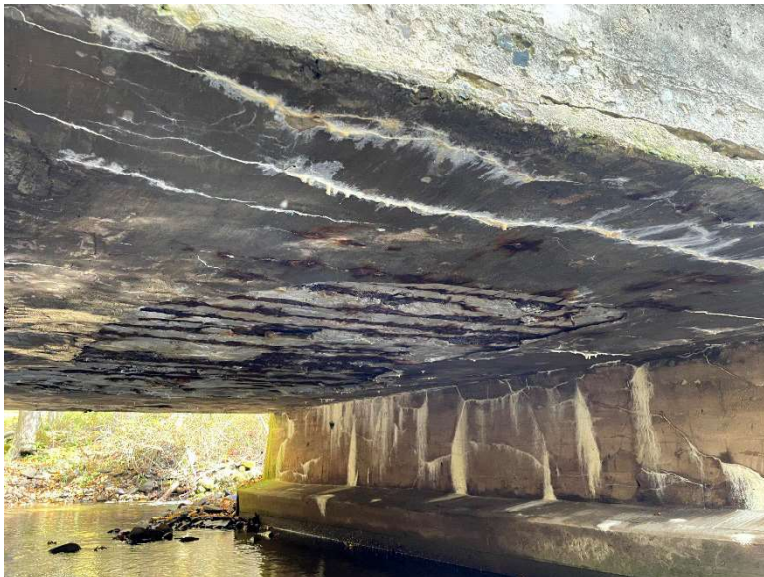
The bituminous pavement has no evidence of cracking in the longitudinal or transverse direction. There is no evidence of deflection. The concrete deck, which was inspected from the underside, has significant spalling of concrete with exposure of corroding reinforcing steel.

Bridge #3 is in fair condition with a rating of 5. A rating of 5 indicates that structural components are sound but due have minor areas of section loss, spalling, cracking and scour. The most significant area of deterioration is spalling of the underside of the concrete deck.

Underside of Deck – Significant Spalling in need of repair

The bridge will require short-term repair involving patching or coating the areas of spalling. The bottom of the abutments will also require additional stone to protect the abutments from erosion and scour at the footing base. The channel (creek bed) shall be monitored streambed protection. The bridge should have a regular inspection schedule to monitor wear over time.

The repair of the underside of the bridge deck may prove to be only temporary. The patching of the spalling areas will likely spall again after continued wear of the surface. The long-term repair will involve replacing the bridge deck with a new deck system.

A short-term repair of spalling conditions on the underside of the bridge deck should be scheduled and budgeted as part of the maintenance of this bridge. Once the repair is made to this bridge, a regular inspection schedule shall be required to monitor the effectiveness of the repairs.
