COOK GEOLOGIC, L.L.C.

**RE: CONDITIONAL USE APPLICATION, MILFORD
TOWNSHIP, PIKE COUNTY PROPERTY: 247 ROUTE 6 -
TAX MAP PARCEL 096.00-01-16**

The purpose of this memorandum is to summarize observations of the sedimentologic characteristics of the above referenced property (the "Site"). These observations were made on August 2 and 3, 2023 as Midlantic Engineering, Inc. was excavating test pits for infiltration testing. Sixteen test pits arrayed around the perimeter of the proposed area of development were examined (Figure 1).

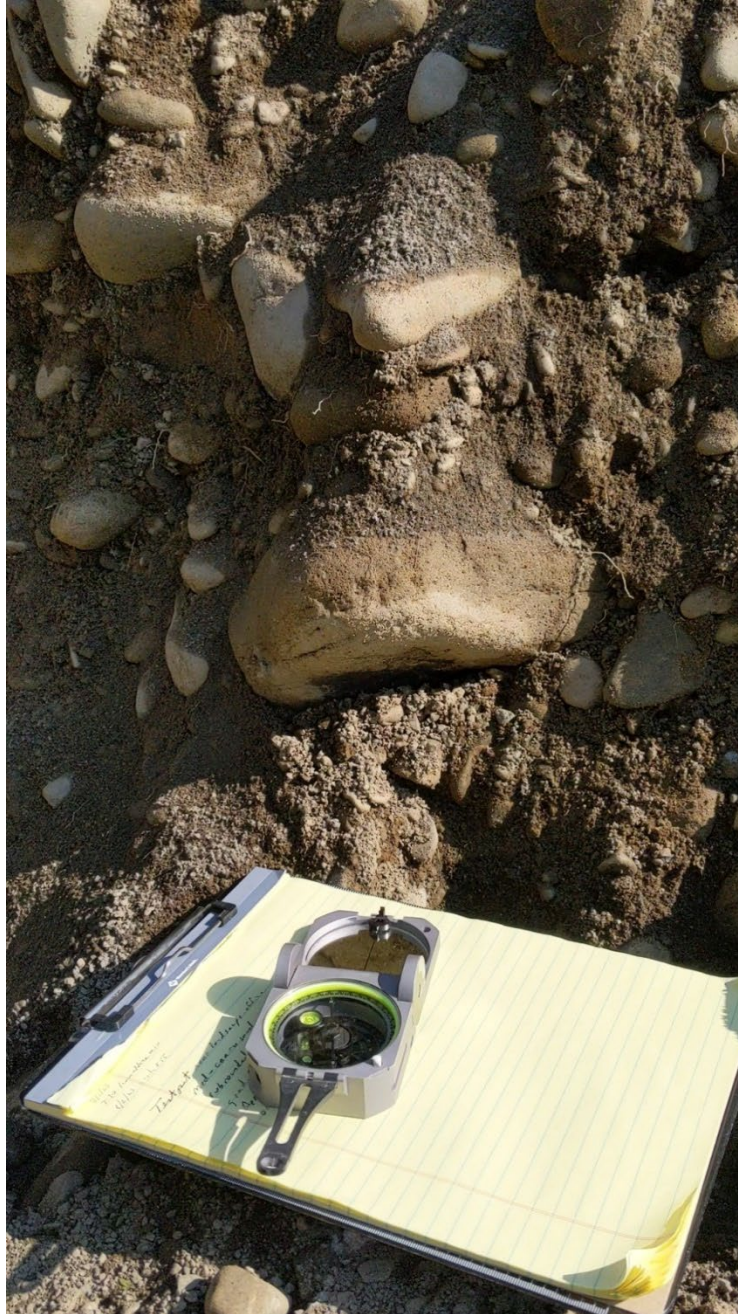
I-6B Rounded to well-rounded medium sand to cobbles. Poorly sorted, not graded. No bedding or sedimentary structures. Flat cobbles are approximately horizontal, weak imbrication in some cases. There is an apparent preferred long dimension orientation (200°, 198°, 186°, 196°). Total depth 1.5 m.

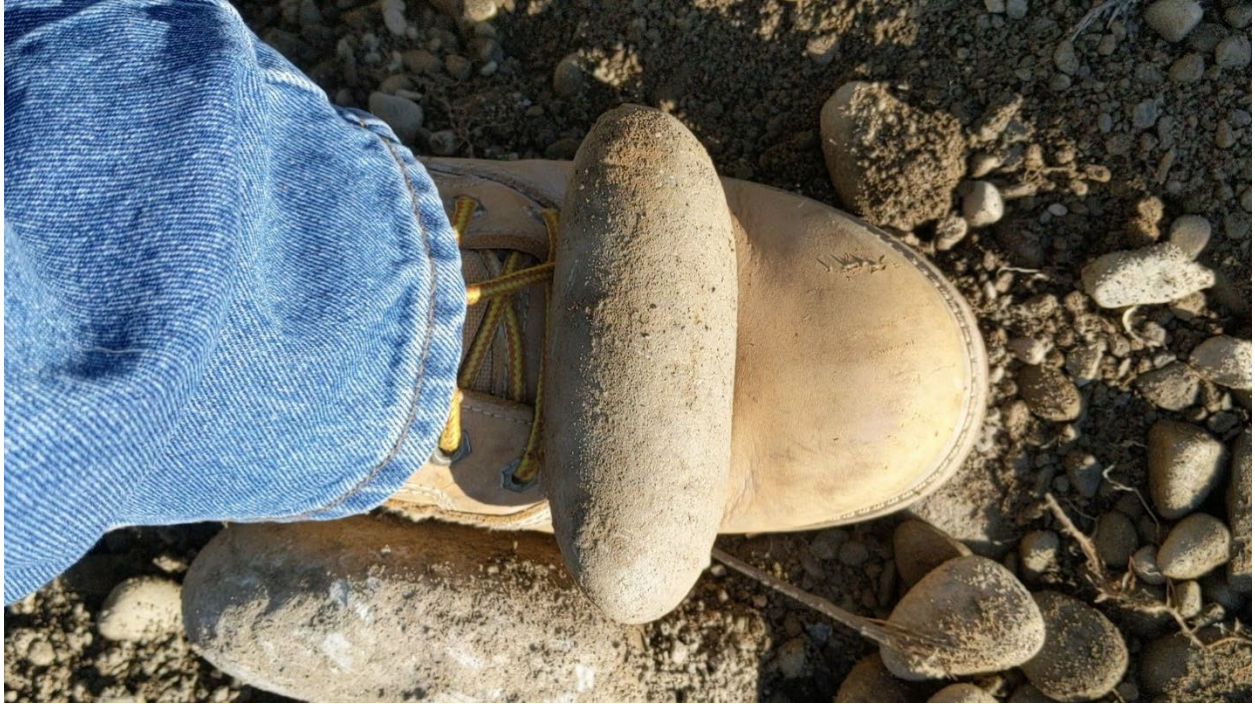
I-6B Well rounded prolate cobble. Cobbles up to ~0.5 m diameter are present. None appear to be faceted or striated.

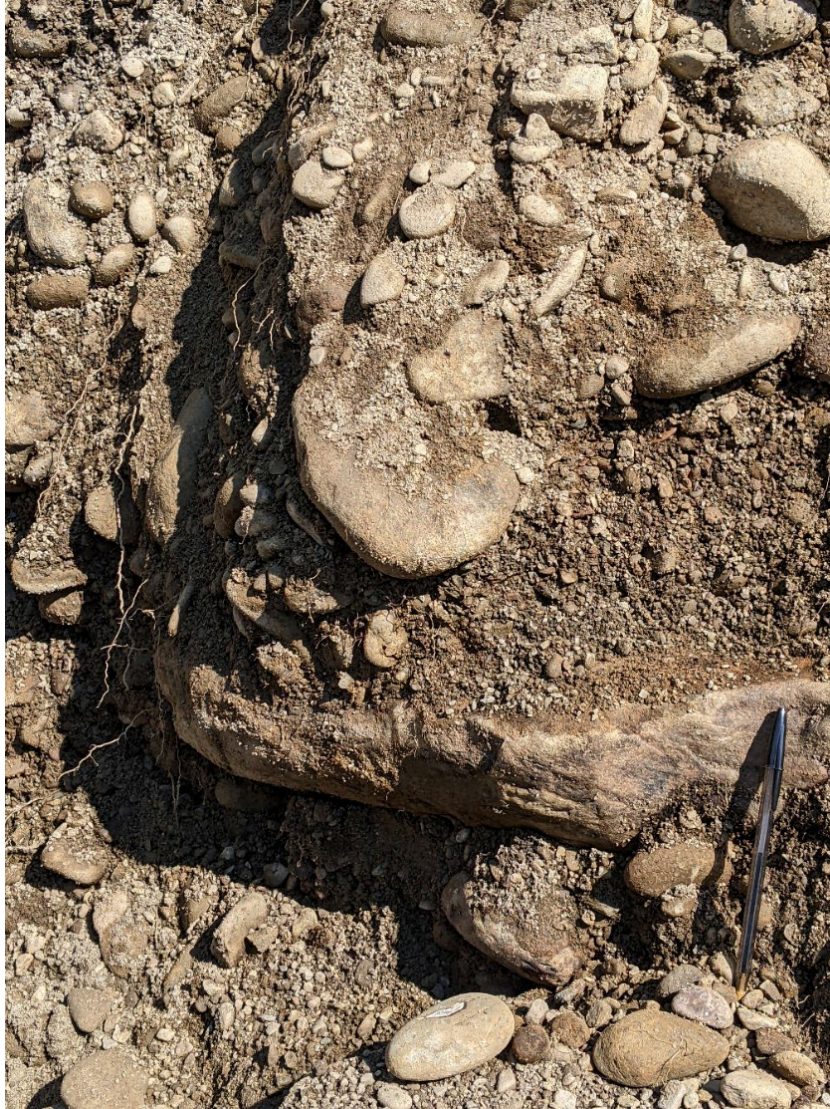
I-6A Rounded to well-rounded medium sand to cobbles. Poorly sorted, not graded. No bedding or sedimentary structures. Flat cobbles are approximately horizontal, weak imbrication in some cases. Apparent preferred long dimension orientations ($\sim 185^\circ$). Total depth 1.4 m.

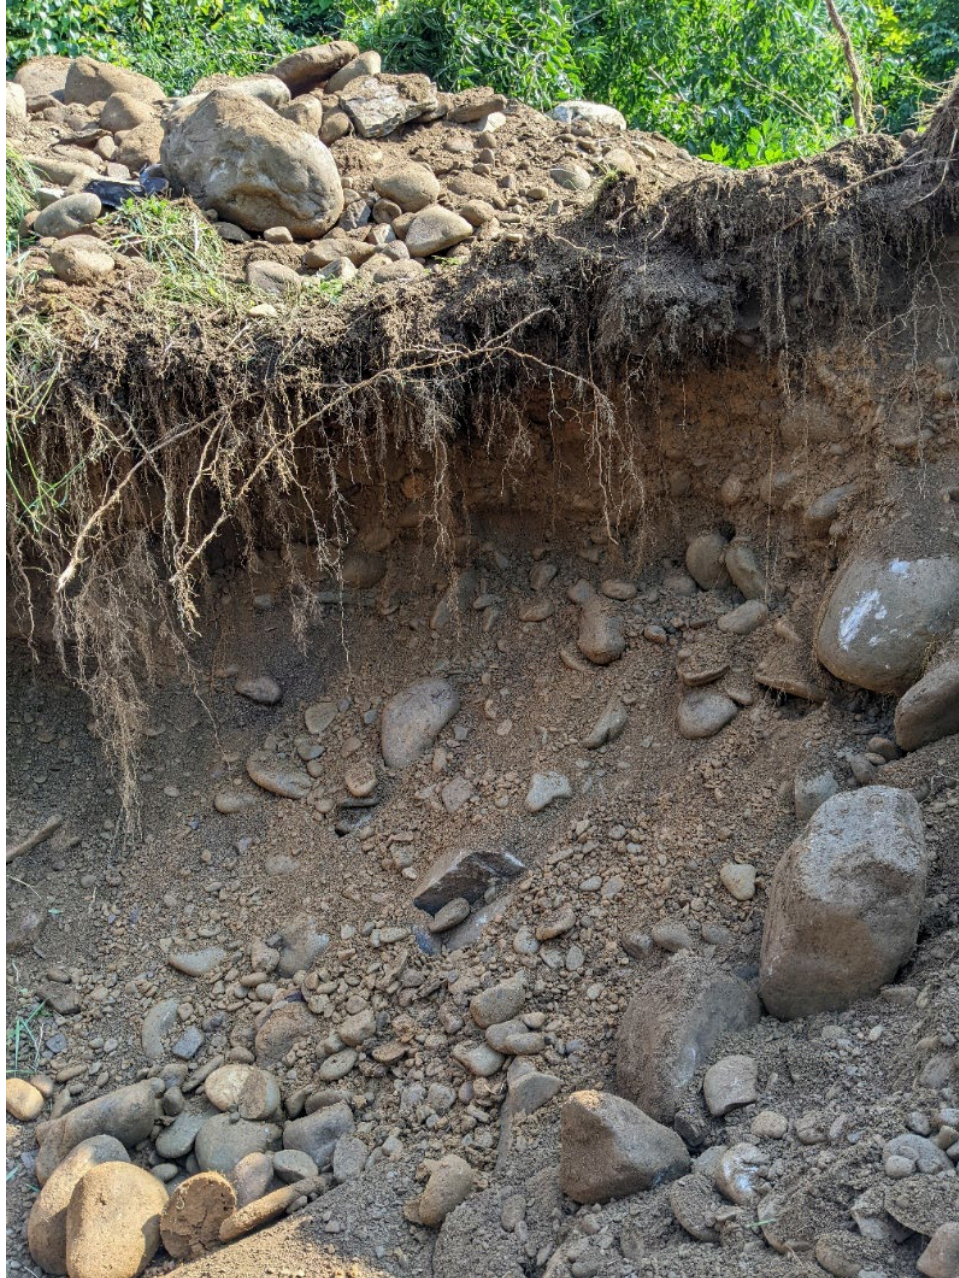
I-5A Medium sand to cobbles. Some fine sand and silt in B-horizon (to ~0.75 m). Total depth 1.5 m.

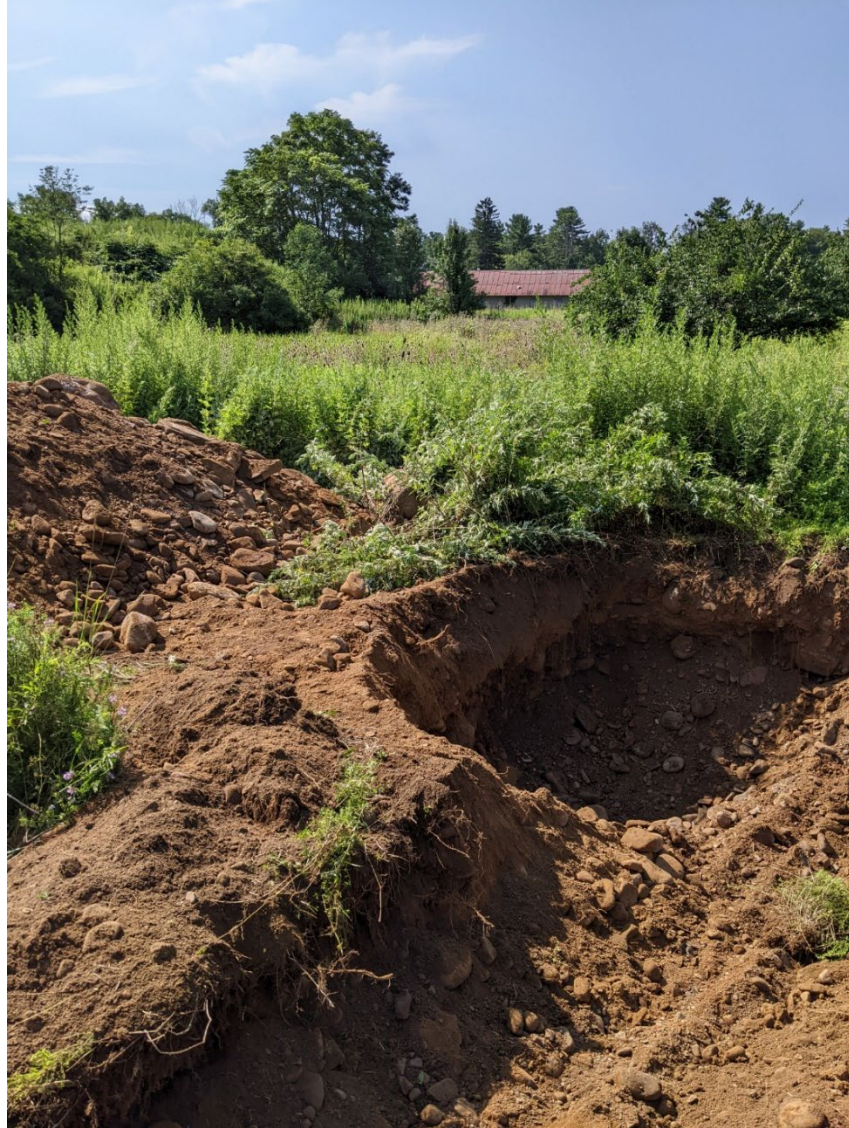
I6C On north (upslope) side of pond. Total depth ~1.5 m.

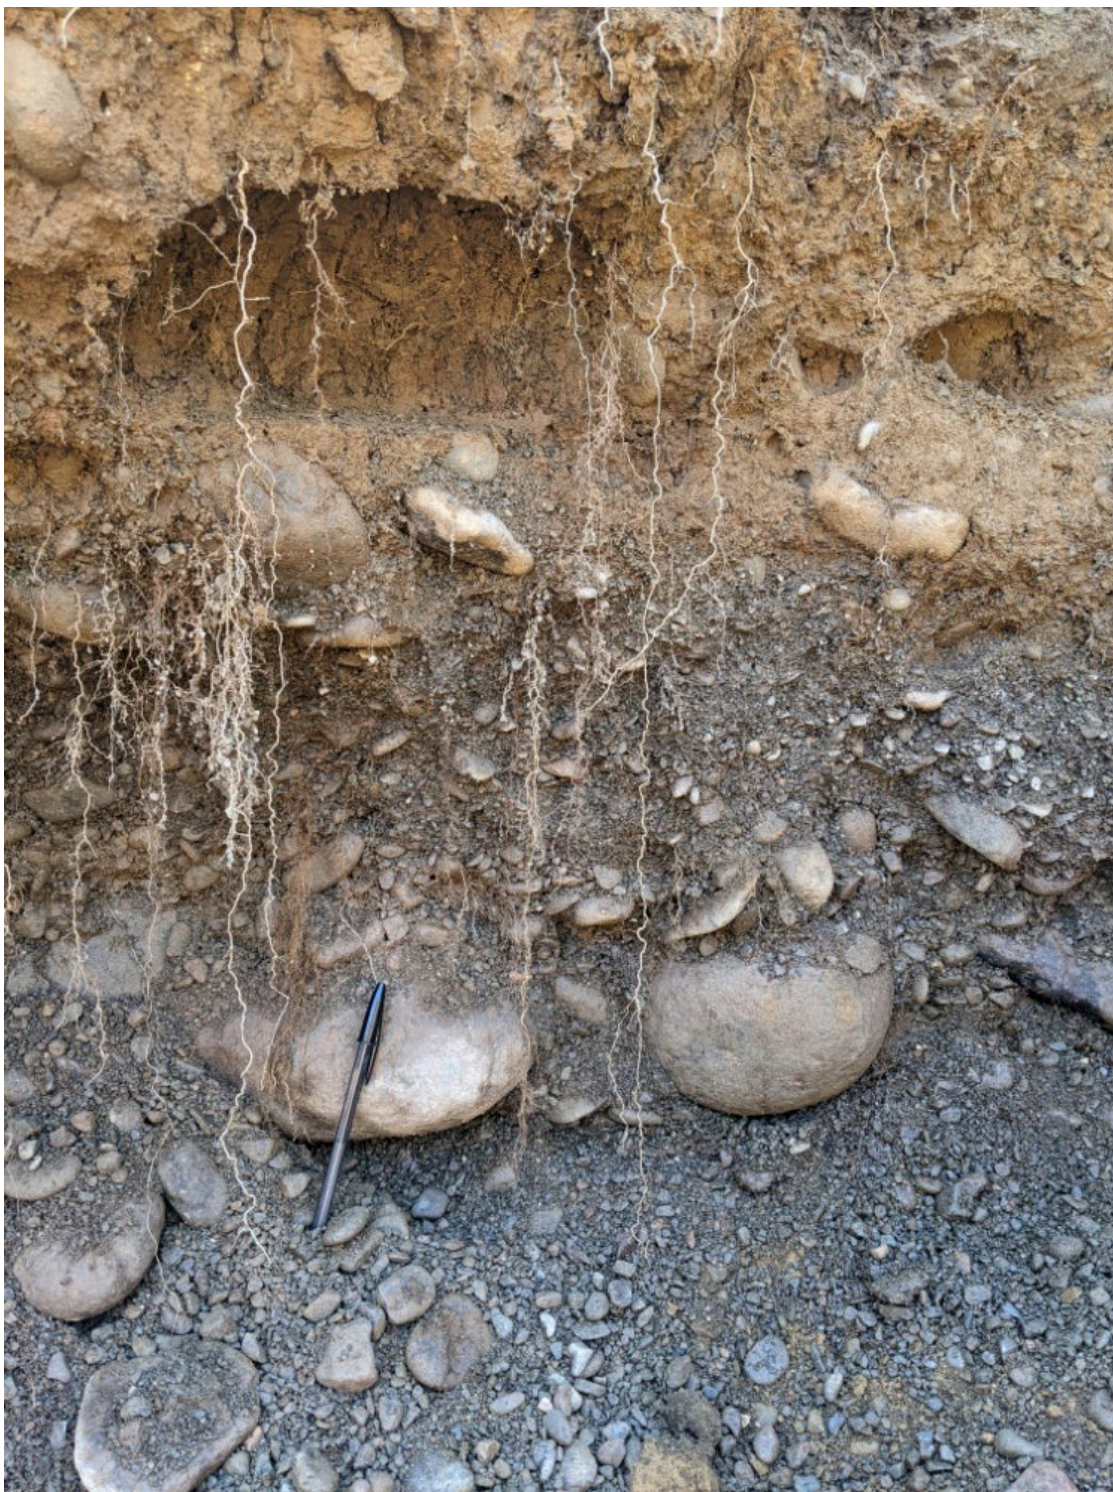
I-6C B-horizon 0-0.5 m silt to cobbles. 0.5 to 0.7 m coarse sand to pebbles. 0.7 to ~1 m coarse sand to cobbles. Layers are approximately horizontal (difficult to measure).

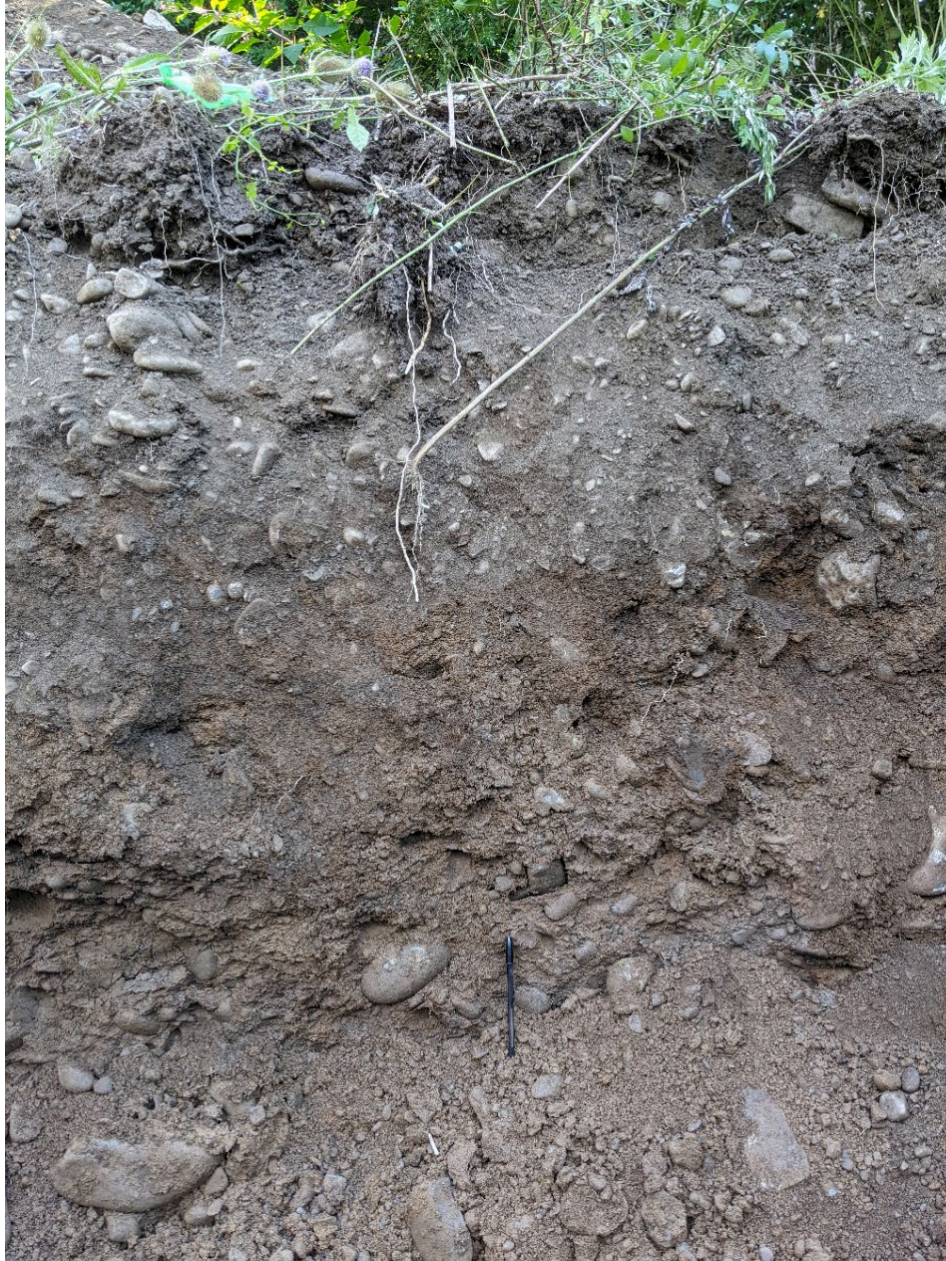
level of ~0.7 m. It was unclear if this was a water table or simply discharge from a locally confined gravel layer of limited extent. The sediment at the bottom of I-6D was moist. The sediment at the bottom of TP-16 was wet.

I-6D At north side of pond. The pond is approximately 1.2 m south with some standing water. Medium sand to cobbles. No sedimentary layering. Pebbles and cobbles are matrix supported. Total depth 1.3 m. Moist at bottom.

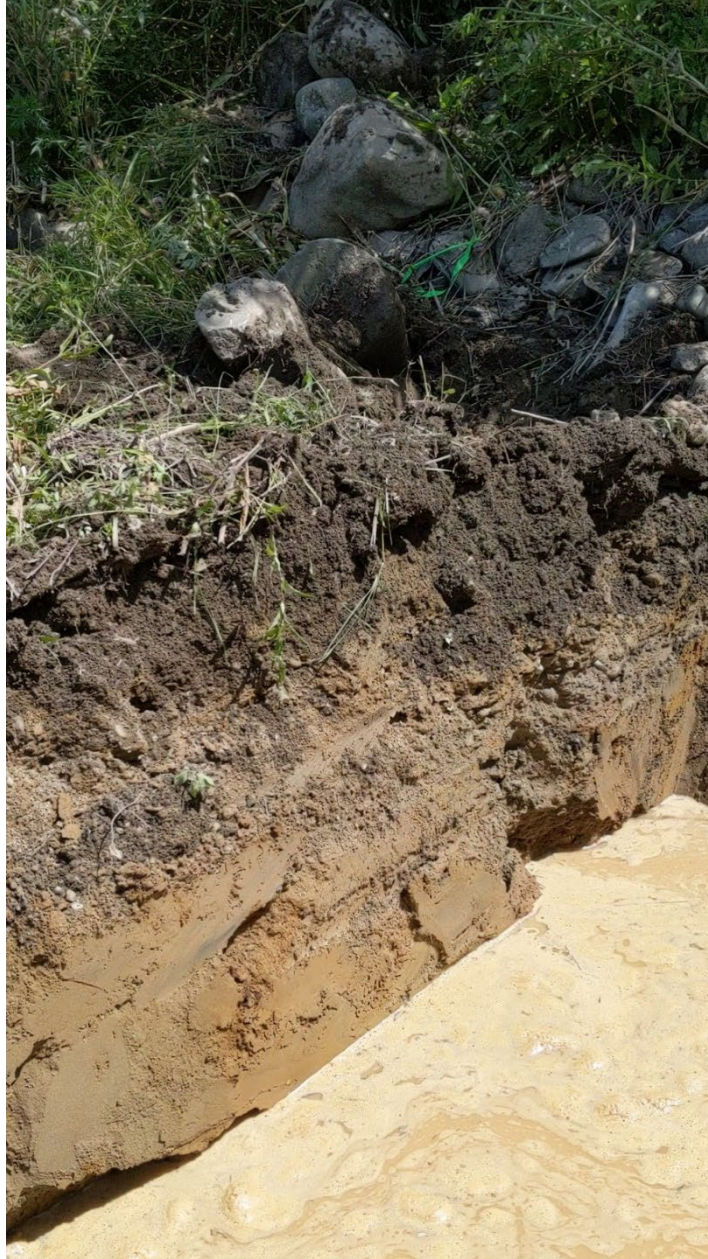
Excavation I-1C exposed only fine sand. The sand appeared predominantly massive but thick laminae (~5 mm) were observed at some locations. Excavation I-6E also exposed primarily massive fine sand. A thin lens of sand and cobbles was also present.

Groundwater was encountered in excavation I-6E. The excavation was initially without water. The water entered the excavation from a gravel layer near the base of the excavation (at ~1.2 m) and subsequently filled the excavation to a

Fine sand deposits observed at locations I-1C and I-6E lacked evidence of transport (ripples, cross-stratification, etc.) and are interpreted as being deposited in small water bodies developed in Kettle holes. These fine sediments may have been transported by wind.

I-6E North wall of excavation adjacent to south side of pond. Fine sand 0 to 1.2 m. Water enters from pebble and cobble layer on west side at bottom. Large cobbles at surface. Small lens of sand and cobbles at 0.5 m in north wall. Water at ~0.7 m.

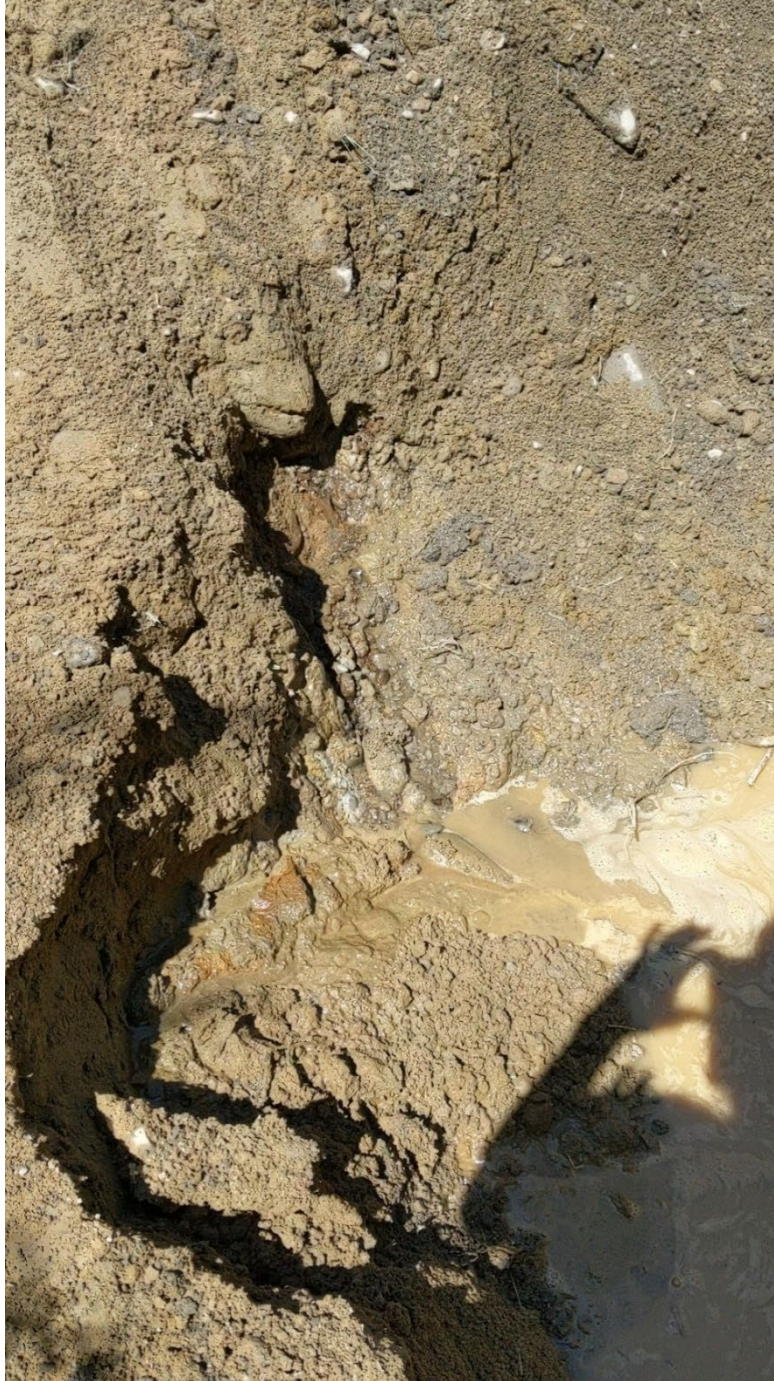
I-6E Water enters from pebble and cobble layer on west side at bottom. Sand, pebbles, and cobbles in west wall of excavation

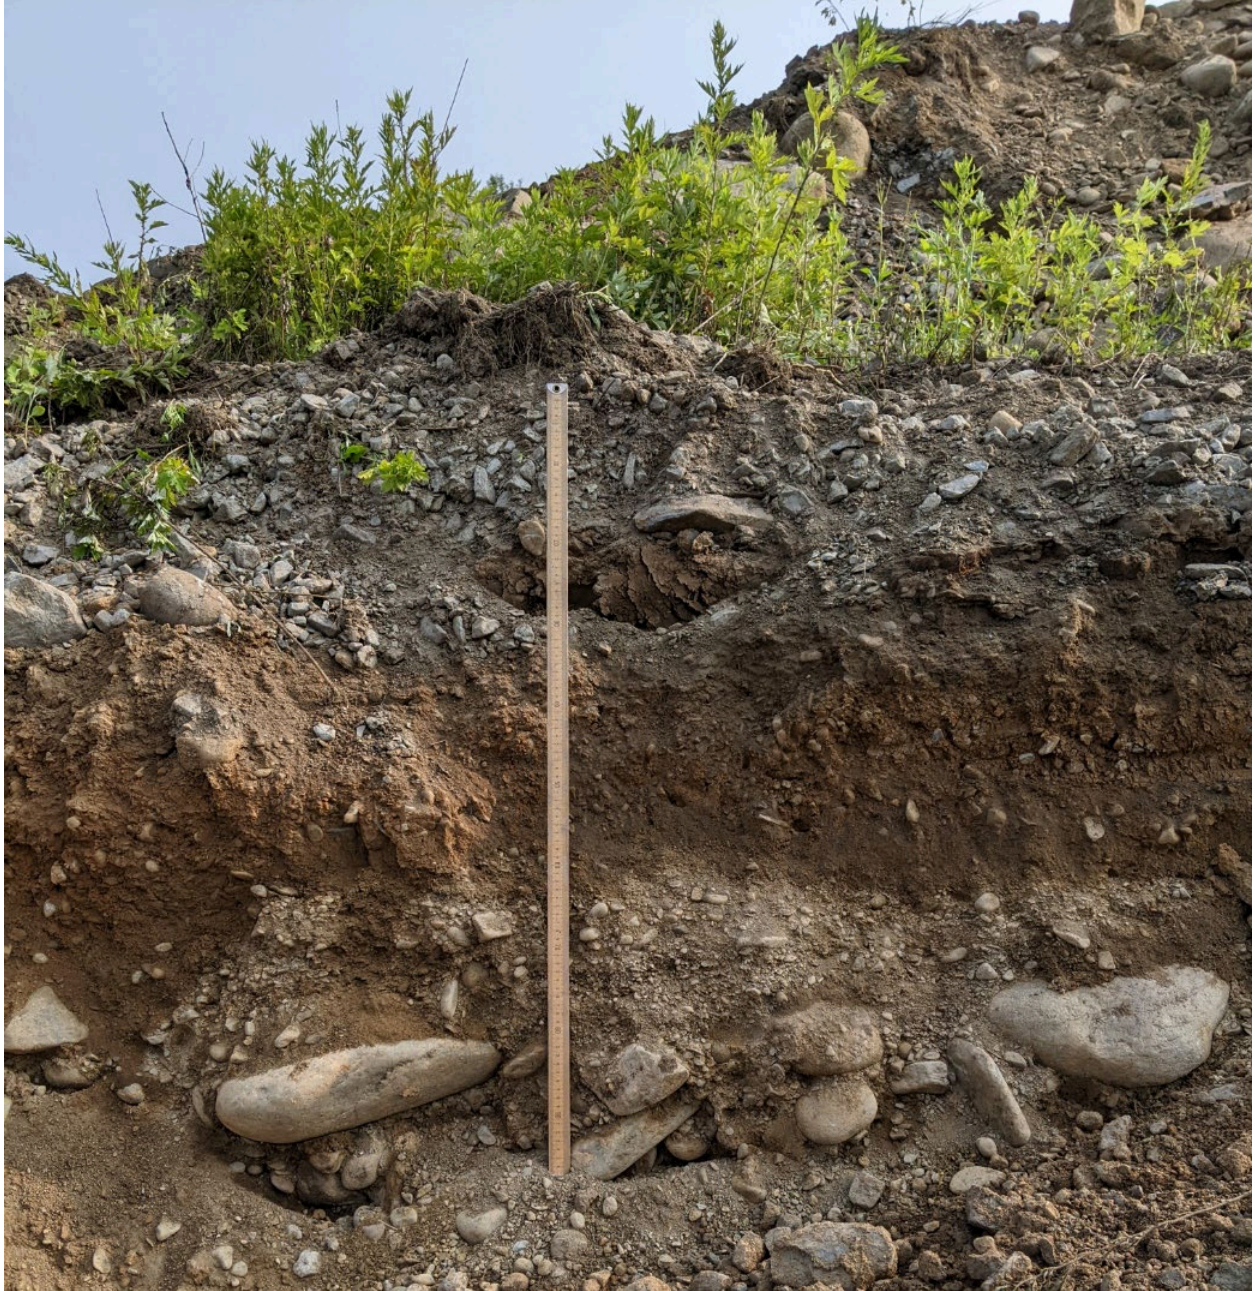
I-4A Medium sand to pebbles with few cobbles layer 0-0.75 m, sand and cobbles 0.75 to bottom (1 m). Layer fines upward. Layer is nearly horizontal (difficult to measure). Some imbrication of cobbles suggests eastward transport.

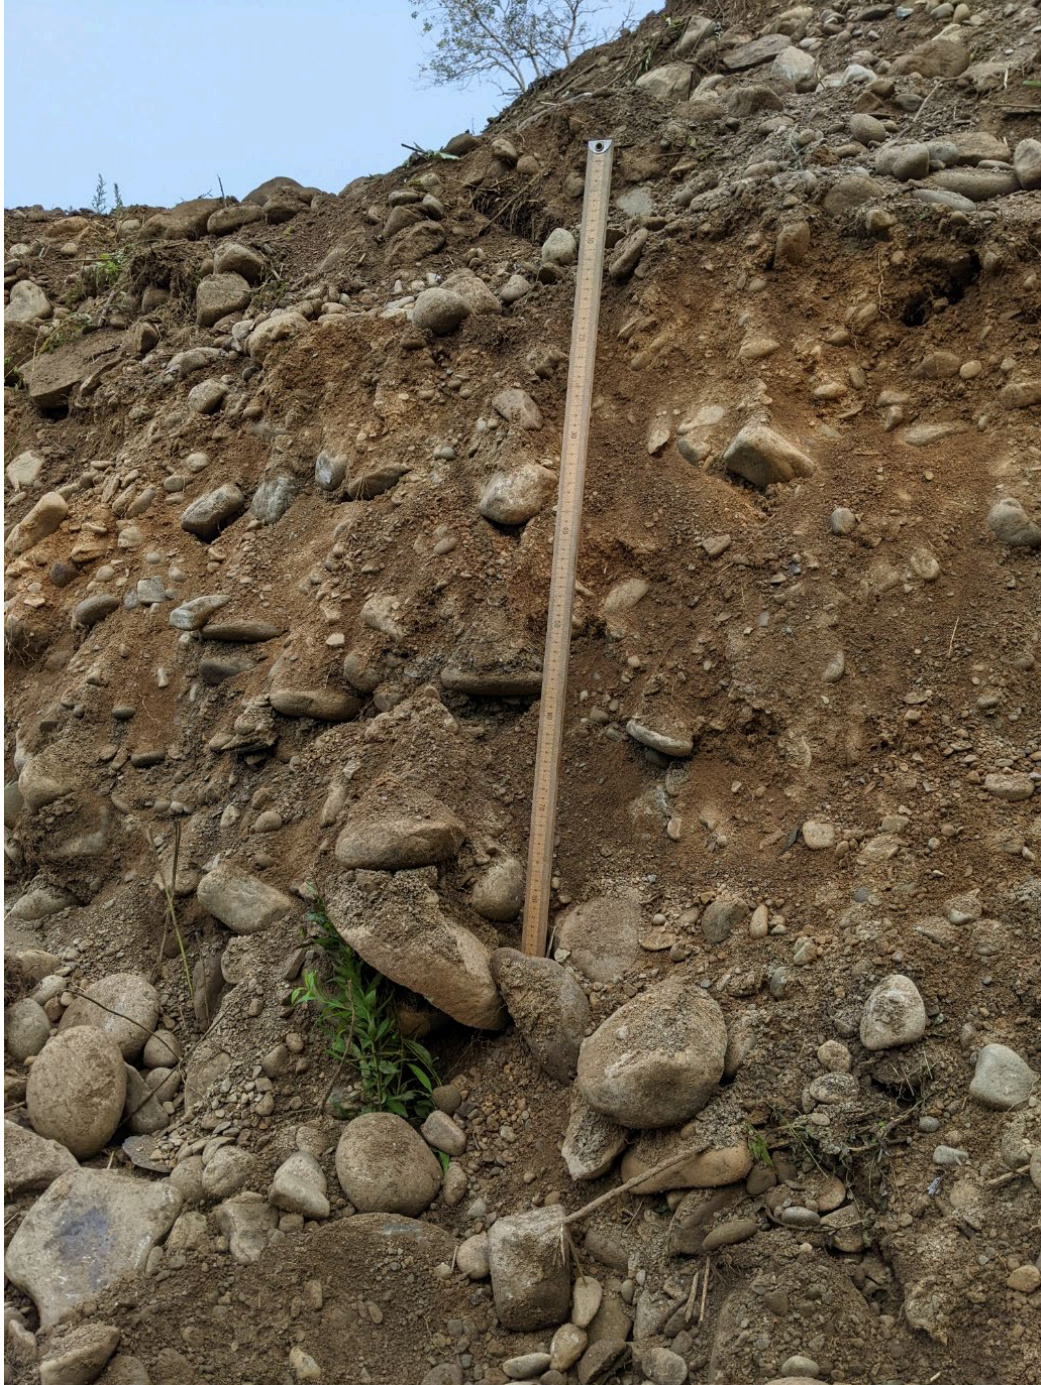
I-4B Medium sand to cobbles. Cobbles are matrix supported.

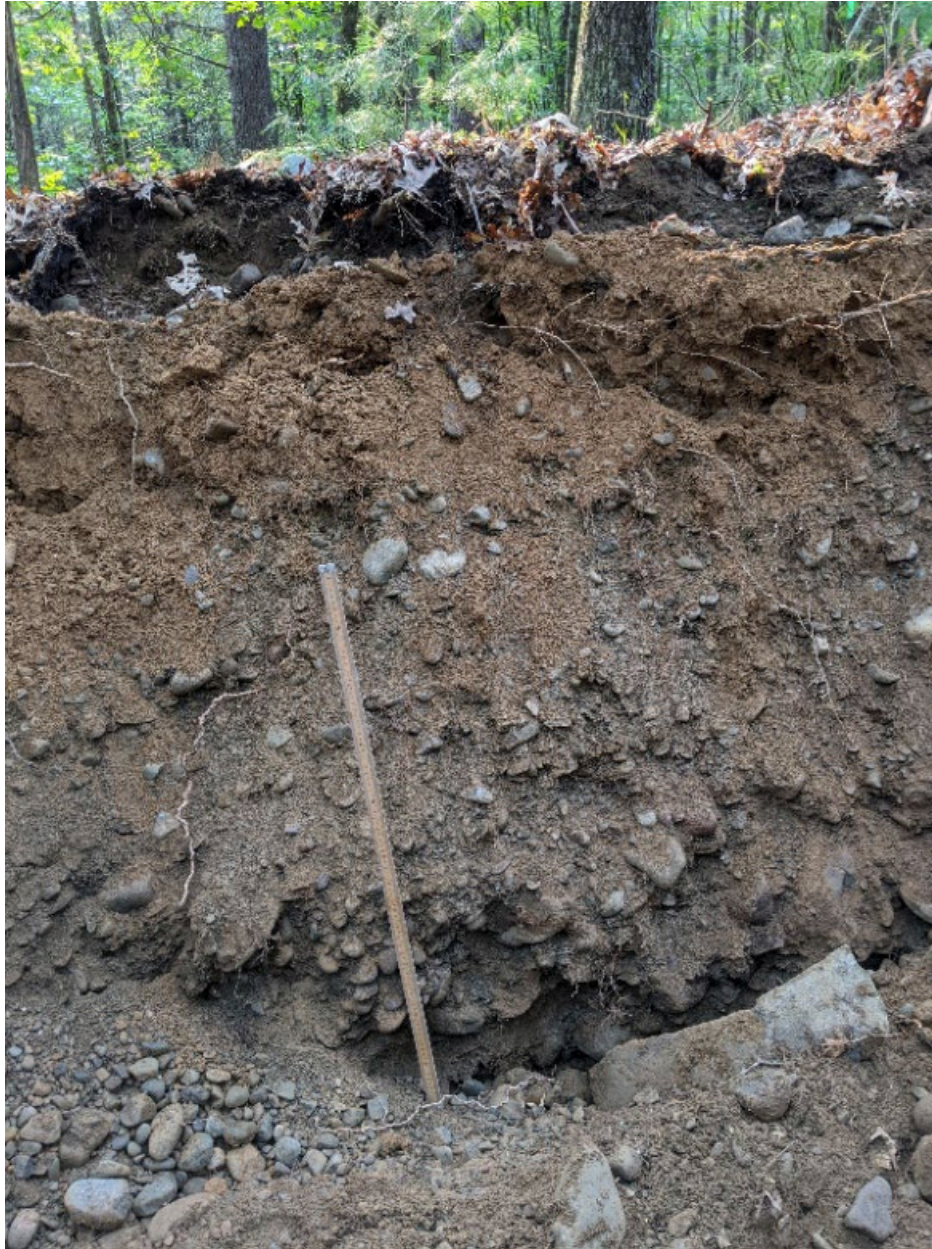
I-4C Medium sand to cobbles.

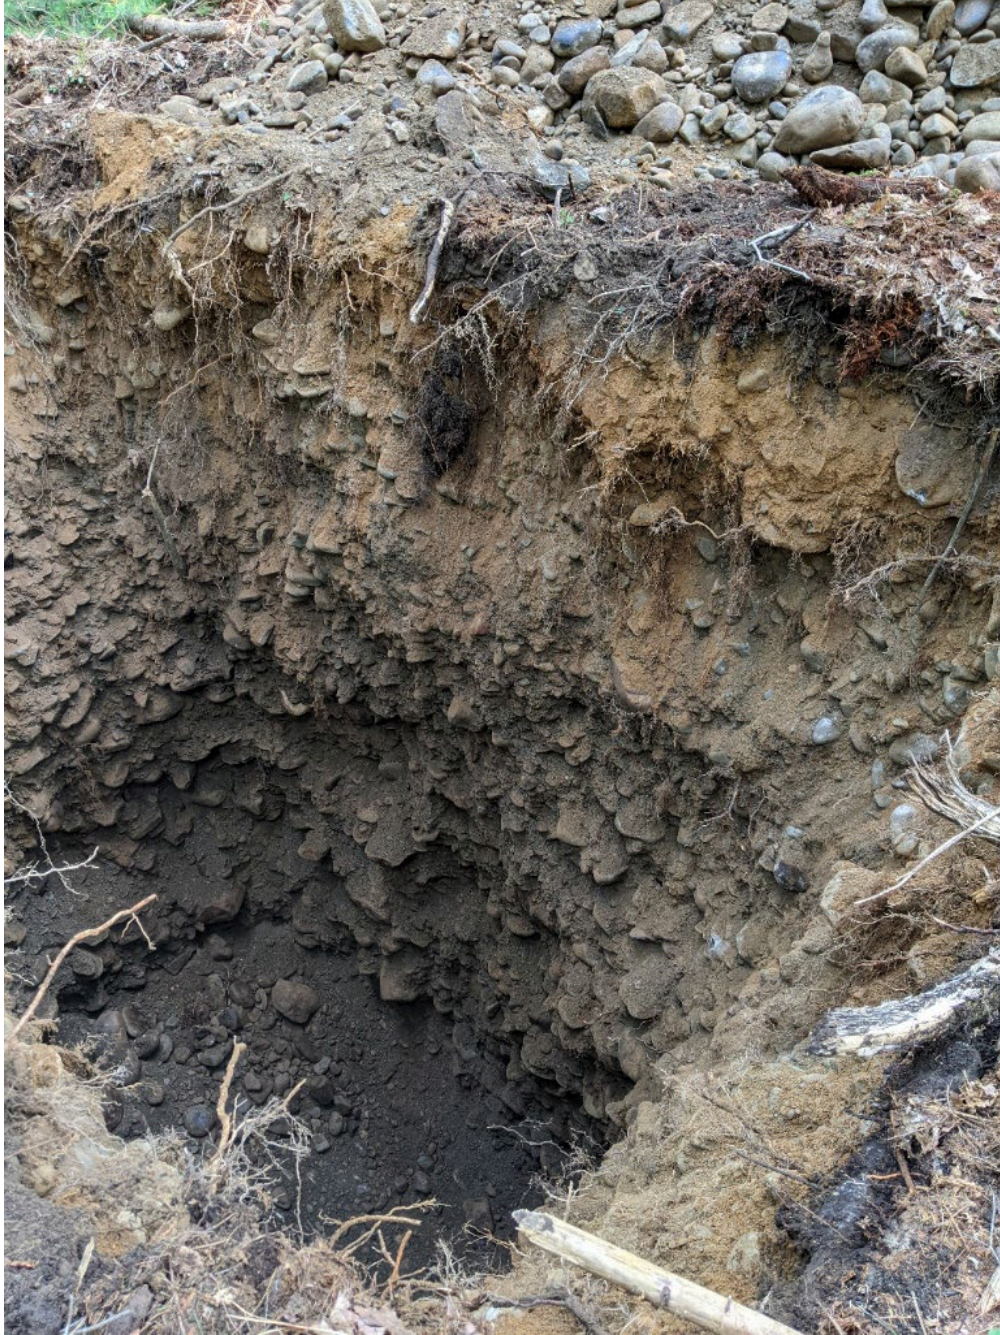
TP-15 Medium sand to cobbles 0-1 m. 1 m to 1.2 m coarse sand layer. 1.2 m to 4.9 m coarse sand and cobbles. Appears to be graded with large cobbles at bottom (up to ~0.5 m) to smaller cobbles to a depth of 1.2 m. Layers are approximately horizontal.

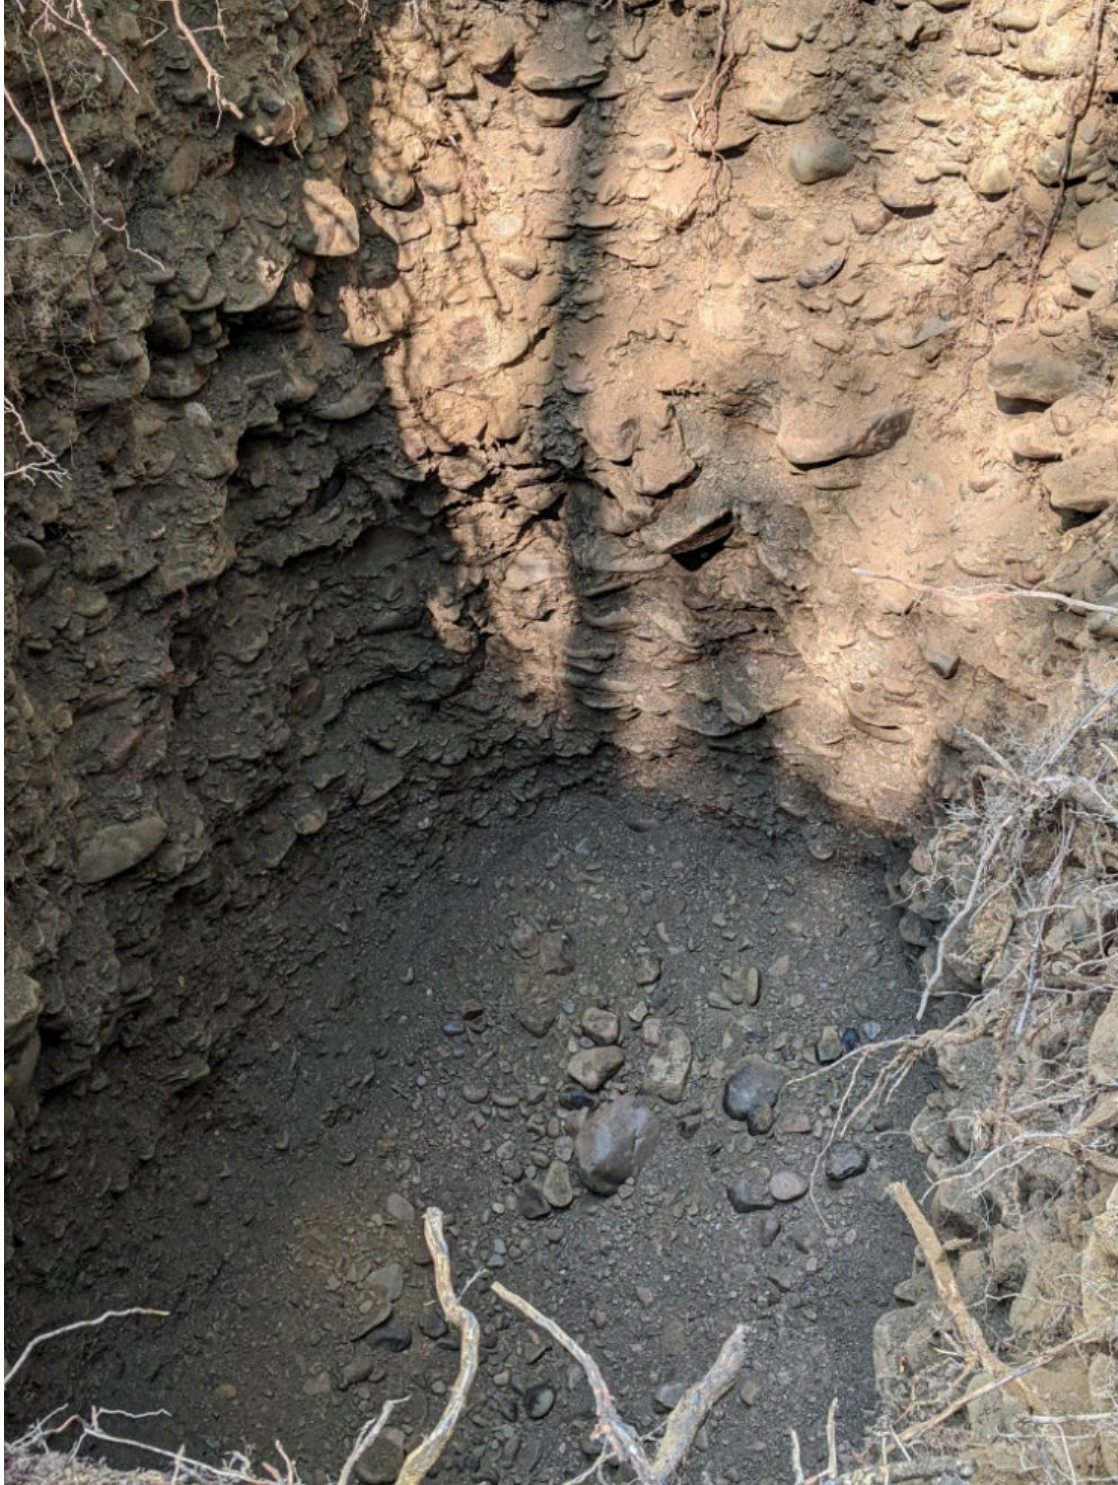
TP-16 Coarse sand to cobbles. Approximately horizontal alignment of cobbles. Slightly finer material near bottom. Total depth 5.2 m. Wet at bottom (no water).

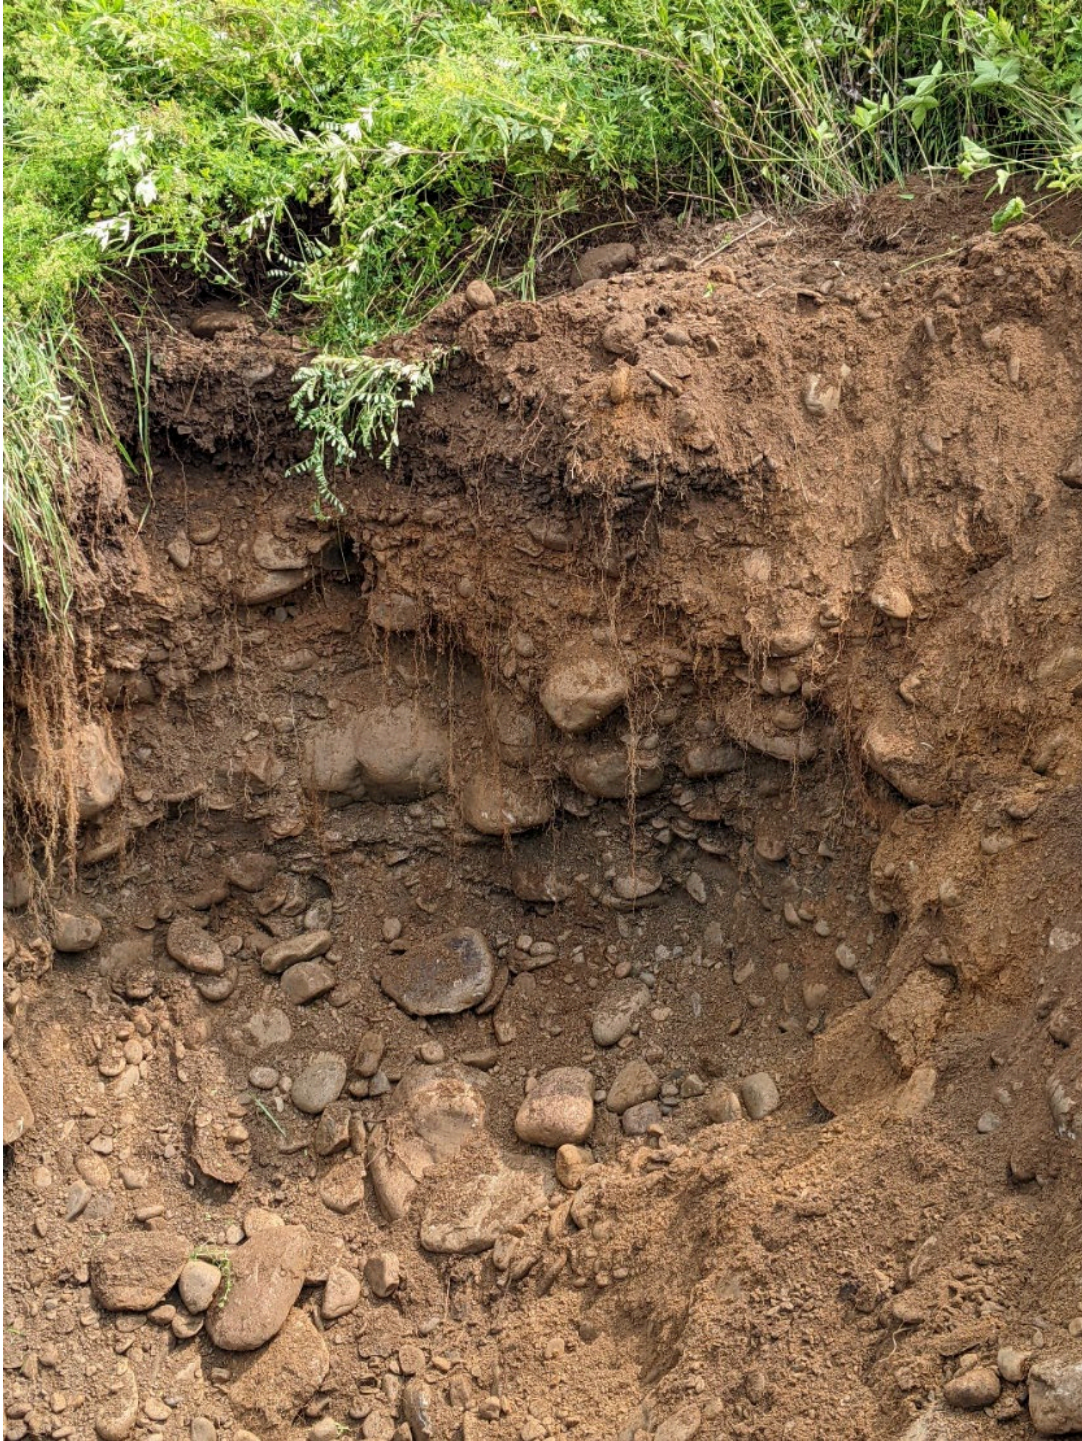
I-1A Medium sand to cobbles. Total depth 1.5 m.

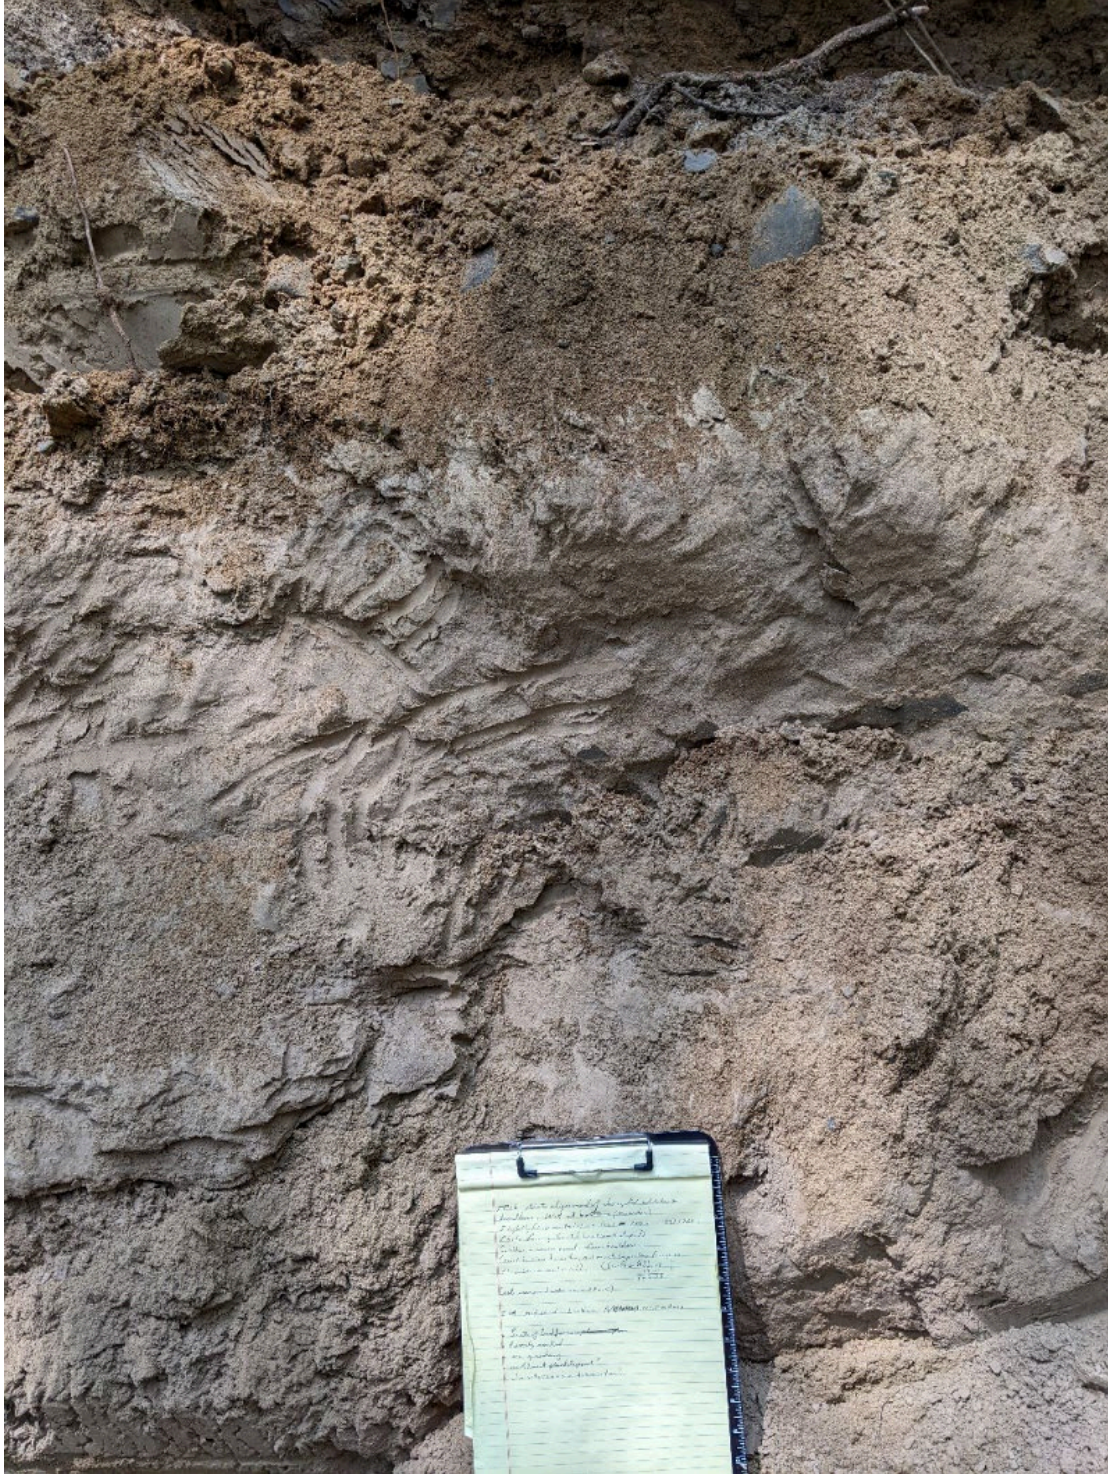
I-1C Fine sand. Platy structure in some areas. Predominantly massive. Thin planer beds are evident in some areas. No ripples or other sedimentary structures. (Relocated to 41.337739, -74.830601)

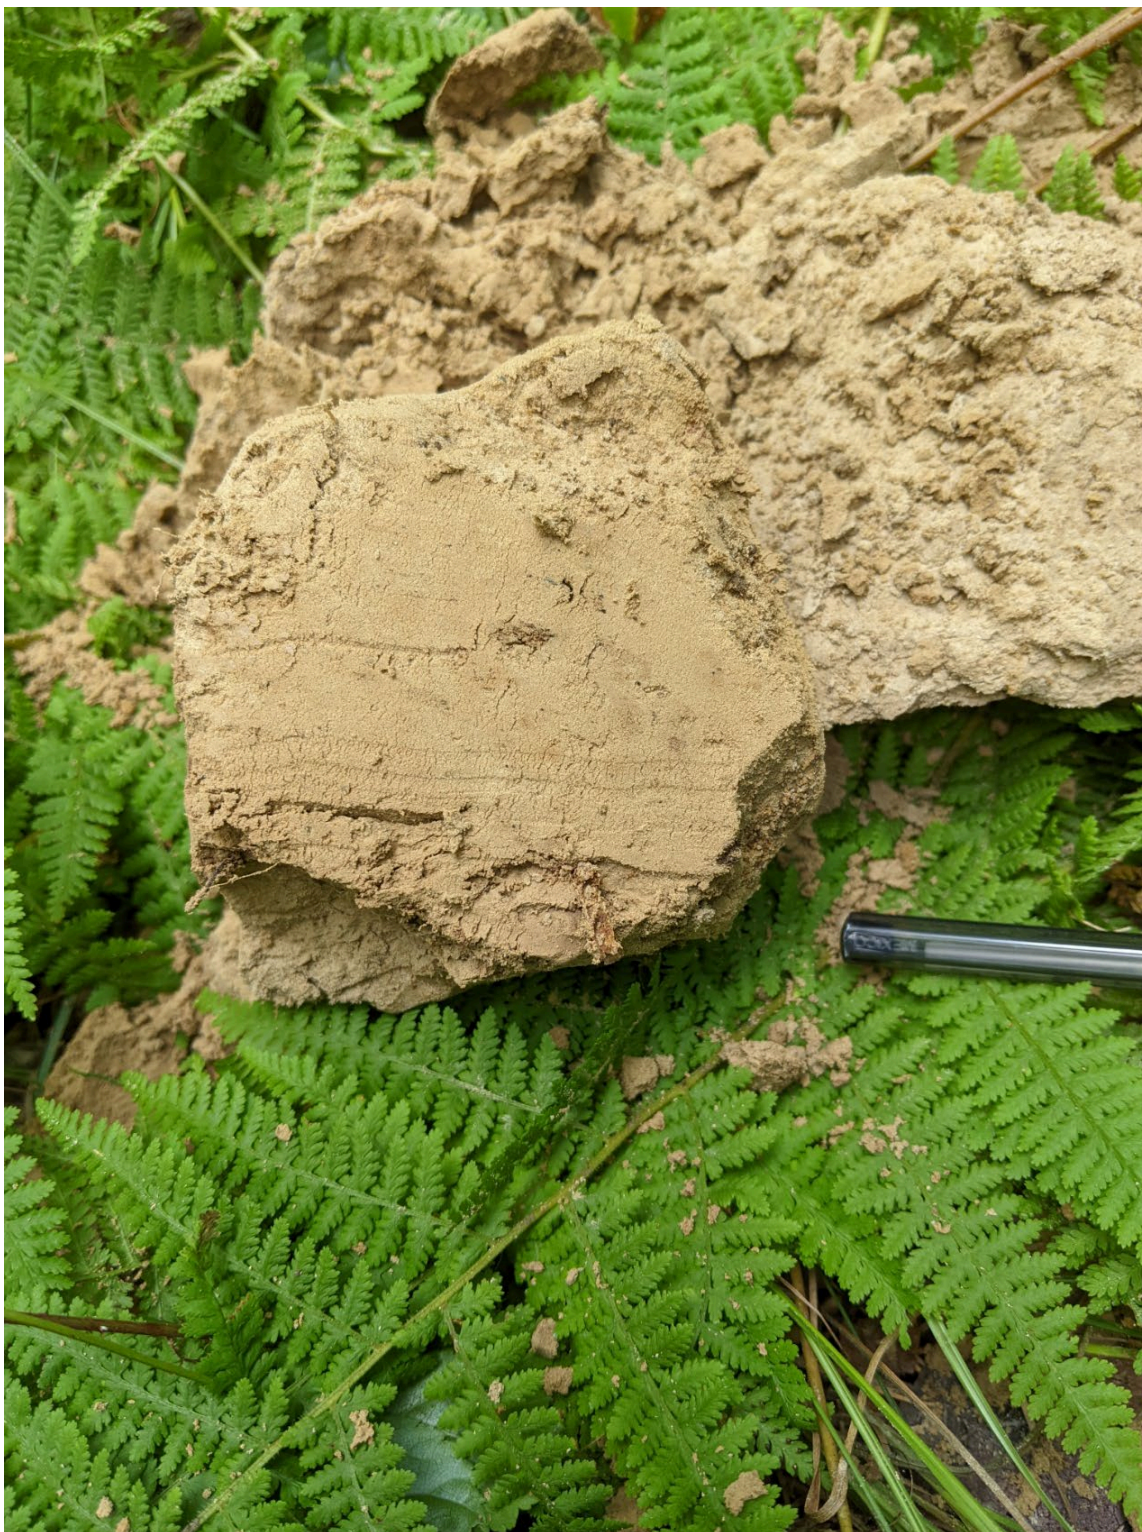
I-1C Fine sand showing thick lamination (~5 mm).
