COOK GEOLOGIC, L.L.C.

**RE: CONDITIONAL USE APPLICATION, MILFORD
TOWNSHIP, PIKE COUNTY PROPERTY: 247 ROUTE 6 -
TAX MAP PARCEL 096.00-01-16**

The purpose of this memorandum is to summarize observations of the sedimentologic characteristics of the above referenced property (the "Site"). These observations were made on August 2 and 3, 2023 as Midlantic Engineering, Inc. was excavating test pits for infiltration testing. Sixteen test pits arrayed around the perimeter of the proposed area of development were examined (Figure 1).

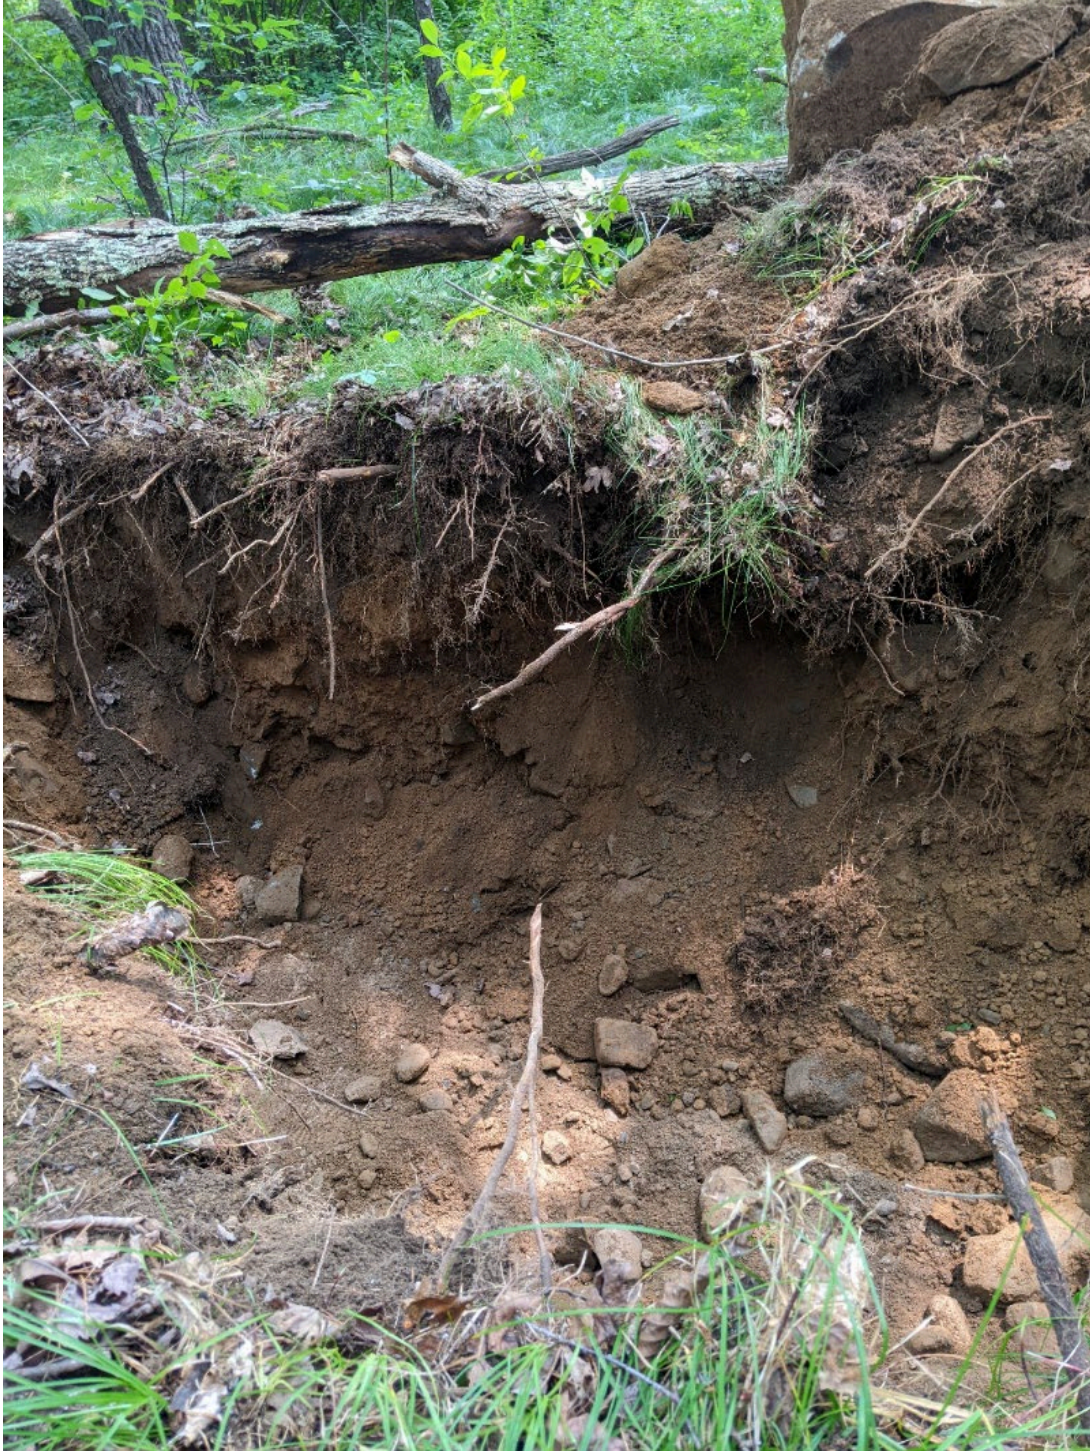
I-1B Medium sand to cobbles. Large cobbles at base (difficult excavation). Total depth 1.5 m.

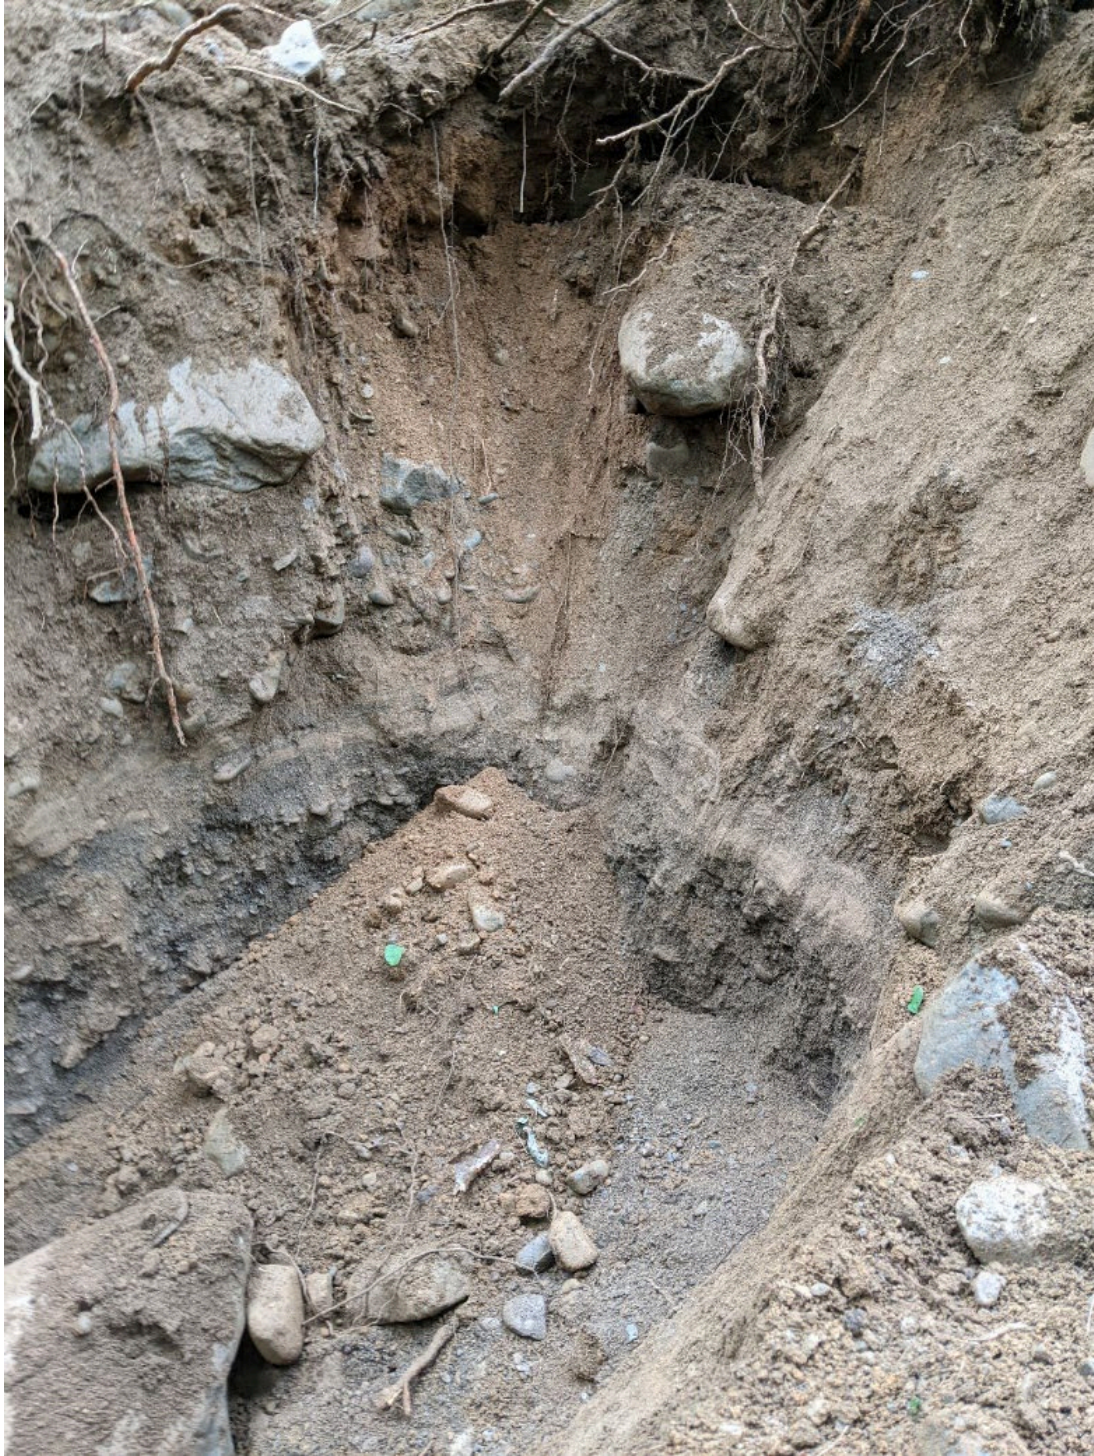
Photographs and field descriptions can be found in Exhibit 1. All excavations, except for I-1C and I-6E, exposed poorly sorted medium sand to cobbles. The largest cobbles were up to ~0.5 m in longest dimension. The pebbles and cobbles were sandstone and were well rounded. At location 1-4B, the cobbles appeared to be matrix supported (i.e., they appeared to float in a sand matrix). At locations I-2A, I-4A, and TP-15, graded, but still poorly sorted, bedding was present. No cross-stratification was observed. At location I-4A some cobbles exhibited weak imbrication suggesting eastward sediment transport. At locations I-6A and I-6B some cobbles exhibited weak imbrication and elongated cobbles exhibited preferred orientation suggesting south-southwestward sediment transport. Bedding, where observed, was approximately horizontal at all locations except for I-2A. At I-2A, bedding dipped 130°, 23° (i.e., southeastward).

I-2A Medium sand to cobbles 0 to 1.2 m. Medium sand and medium sand to cobble layers at bottom. Layers dipping $\sim 130^\circ$, 23° . Total depth 2.1 m.

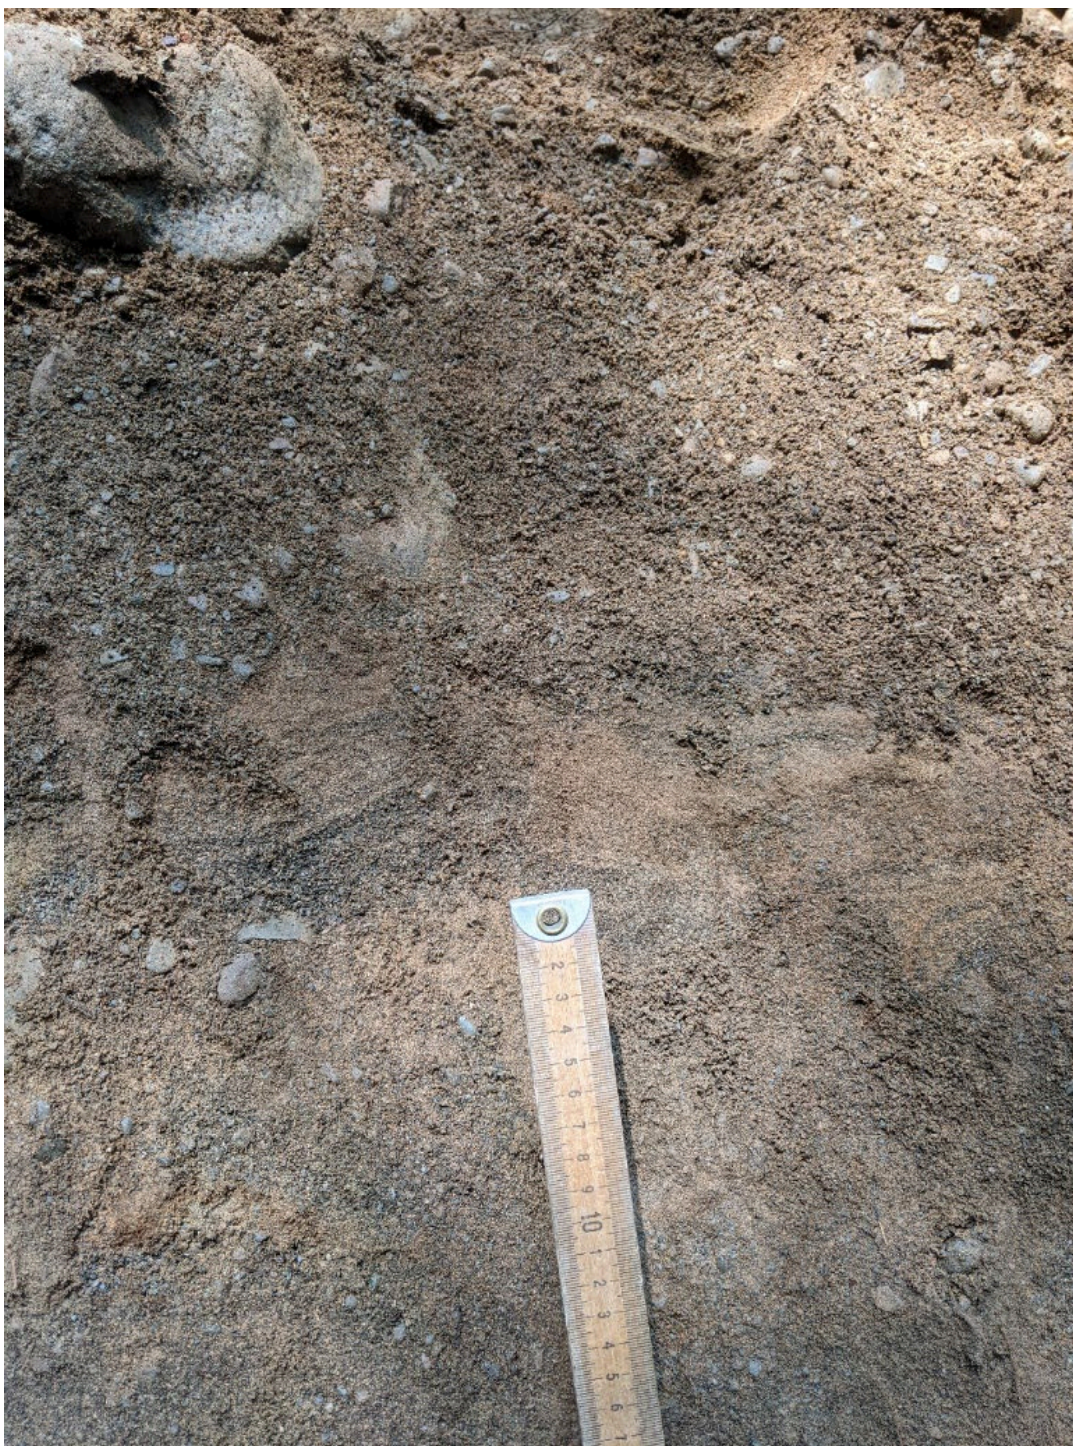
I-2A Medium sand with few granules and pebbles at 1.2 m. Possible small slump structure at top of meter stick.

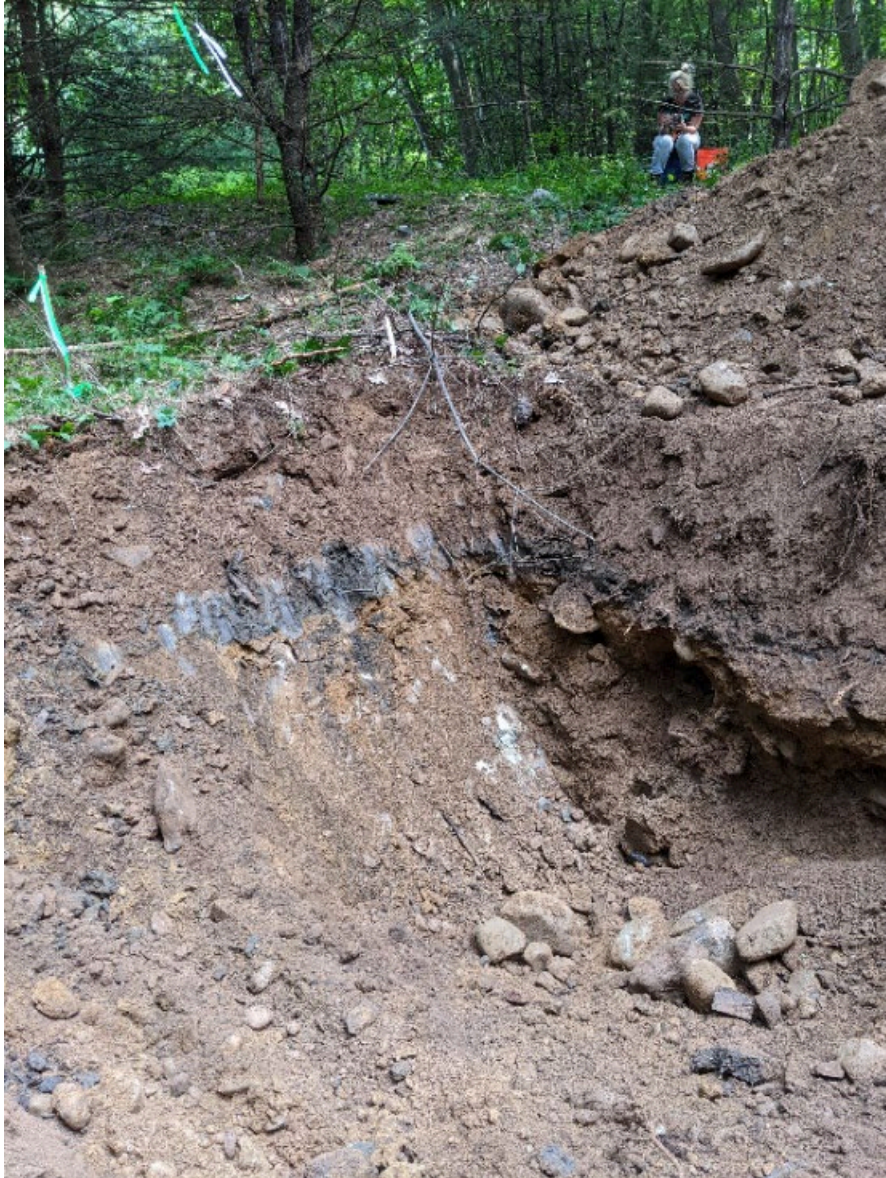
I2-B Old road. Buried A-horizon at 0.7 m. Medium sand to cobbles to 1.5 m.
