GEOTECHNICAL ENGINEERING REPORT

STORMWATER MANAGEMENT AND INFILTRATION TESTING
MILFORD WAREHOUSE DEVELOPMENT
MILFORD TOWNSHIP, PA

(Project #23004-SWM)

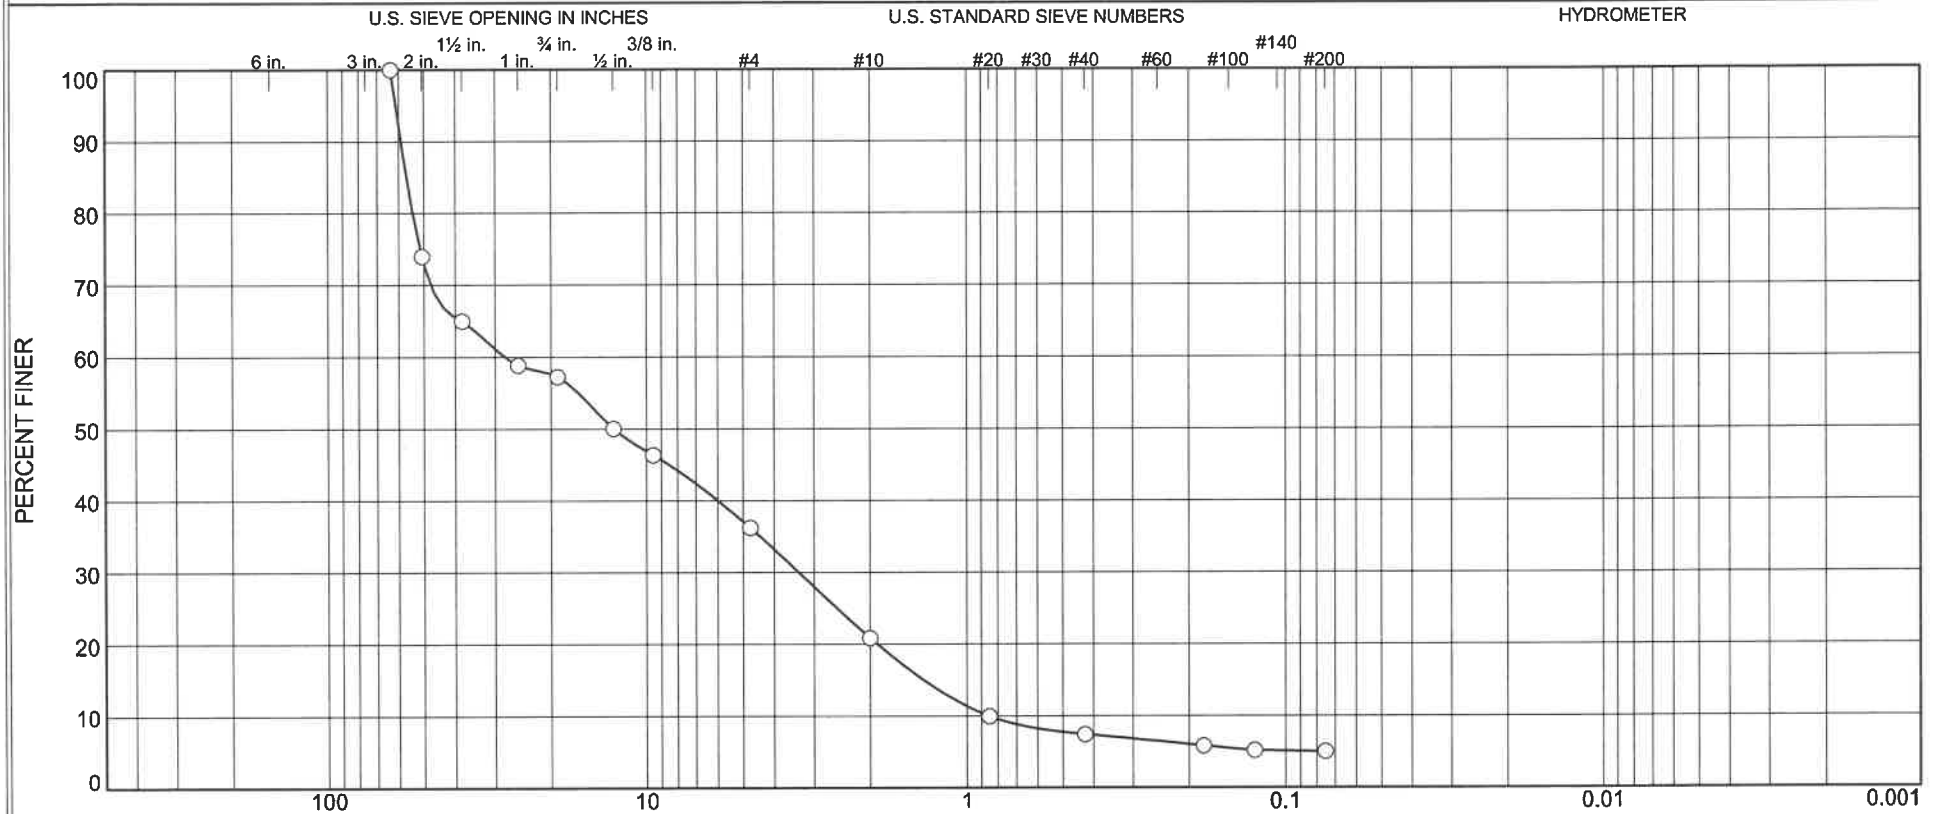
GRADATION AND CLASSIFICATION (ASTM D2487)

% +3"	% Gravel		% Sand			% Fines	
	Coarse	Fine	Coarse	Medium	Fine	Silt	Clay
0.0	42.8	21.0	15.3	13.5	2.4	5.0

Source	Sample #	Depth/Elev.	Date Sampled	USCS	Material Description	NM %	LL	PL
TP-I-1A	S-2	4.8'/890.0	8/4/23	GP-GM	brown poorly graded GRAVEL with silt and sand	4.4	NV	NP
					Stratum B

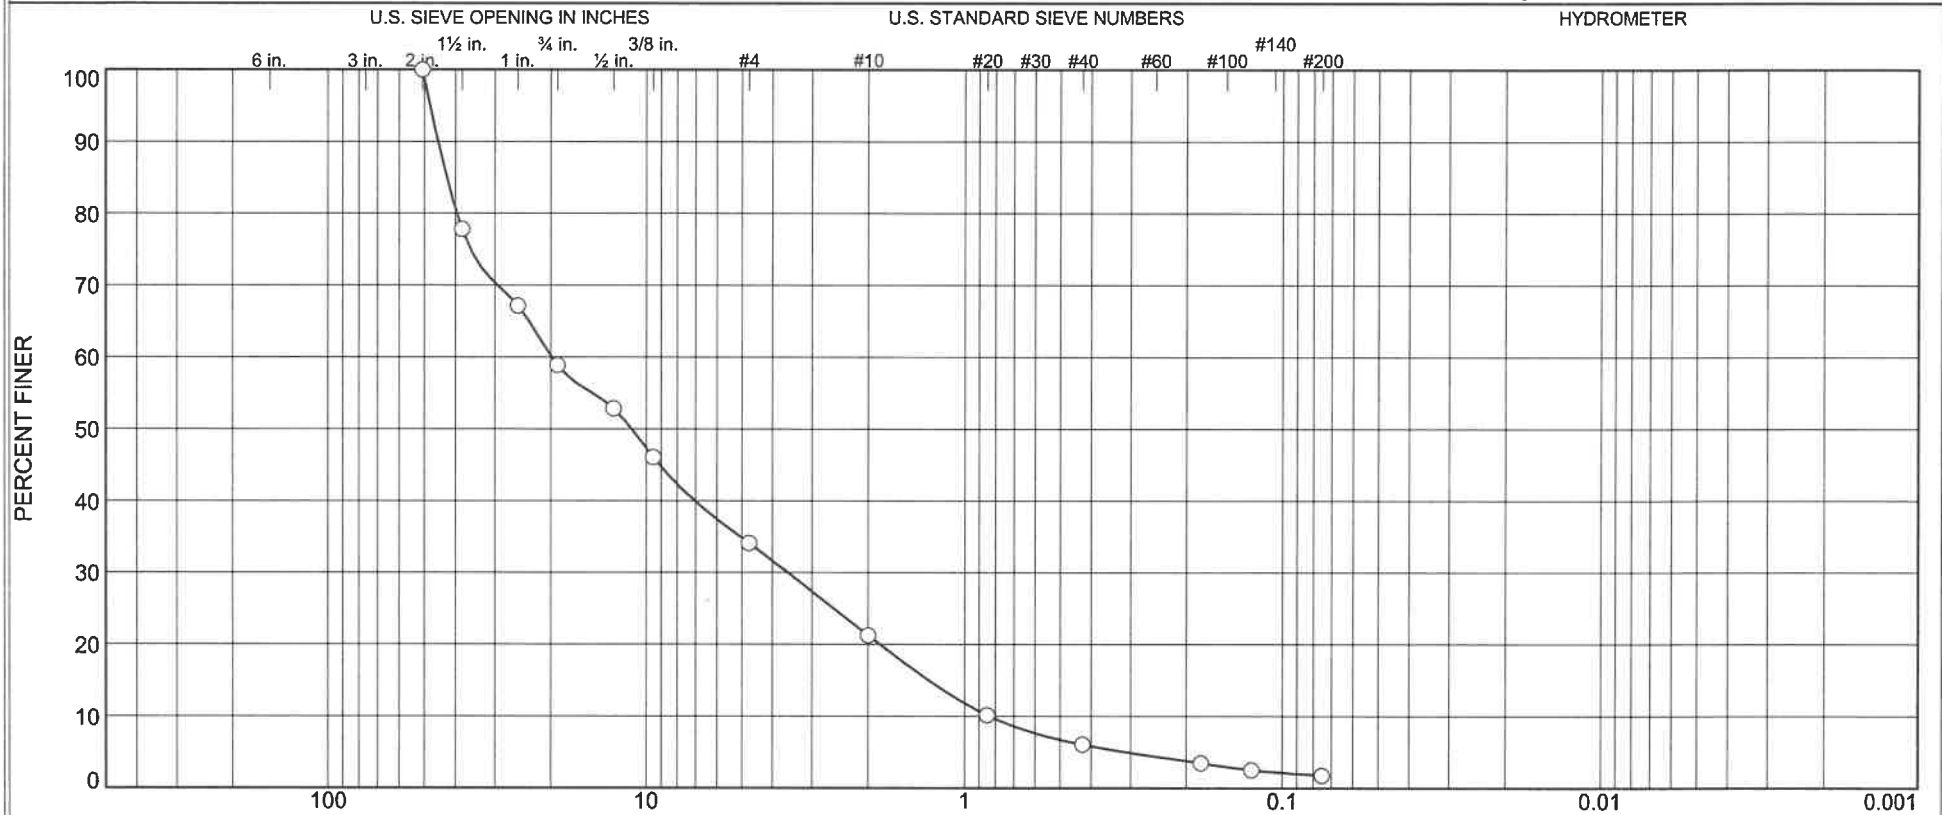
GRADATION AND CLASSIFICATION (ASTM D2487)

GRAIN SIZE - mm.

% +3"	% Gravel		% Sand			% Fines	
	Coarse	Fine	Coarse	Medium	Fine	Silt	Clay
0.0	41.1	24.8	12.8	15.2	4.3	1.8

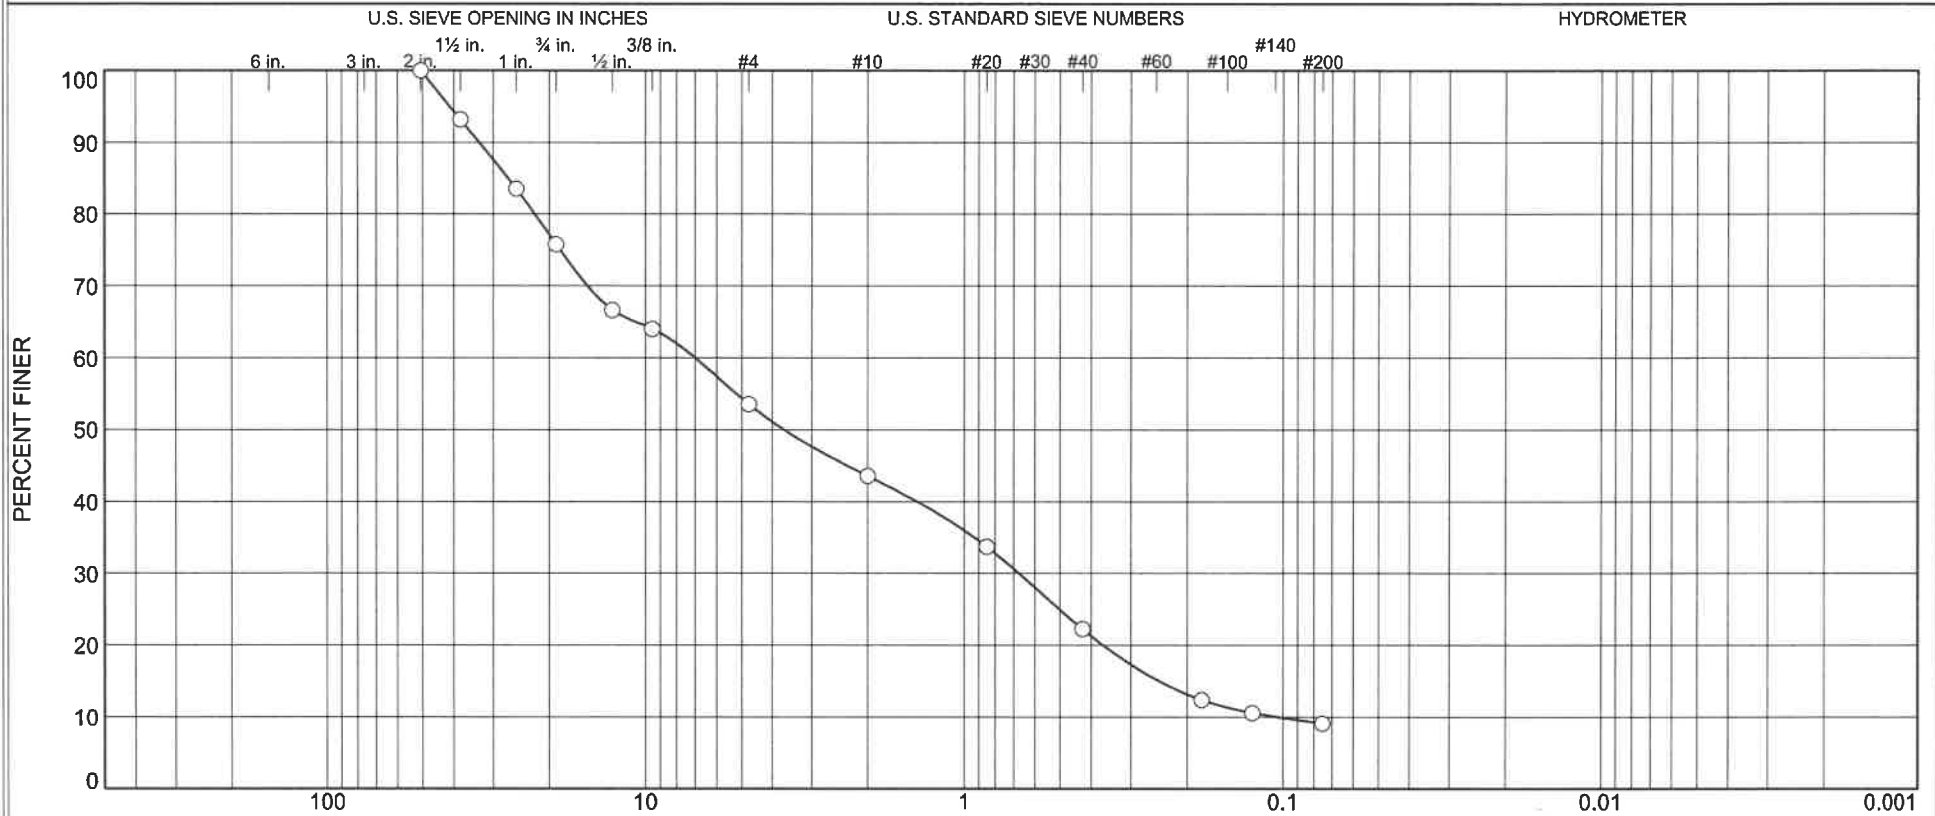
GRADATION AND CLASSIFICATION (ASTM D2487)

% +3"	% Gravel		% Sand			% Fines	
	Coarse	Fine	Coarse	Medium	Fine	Silt	Clay
0.0	24.2	22.2	10.0	21.3	13.2	9.1

Source	Sample #	Depth/Elev.	Date Sampled	USCS	Material Description	NM %	LL	PL
TP-I-2A	S-2	4.8'/868.0	8/4/23	GP-GM	brown poorly graded GRAVEL with silt and sand	6.3	NV	NP
					Stratum B

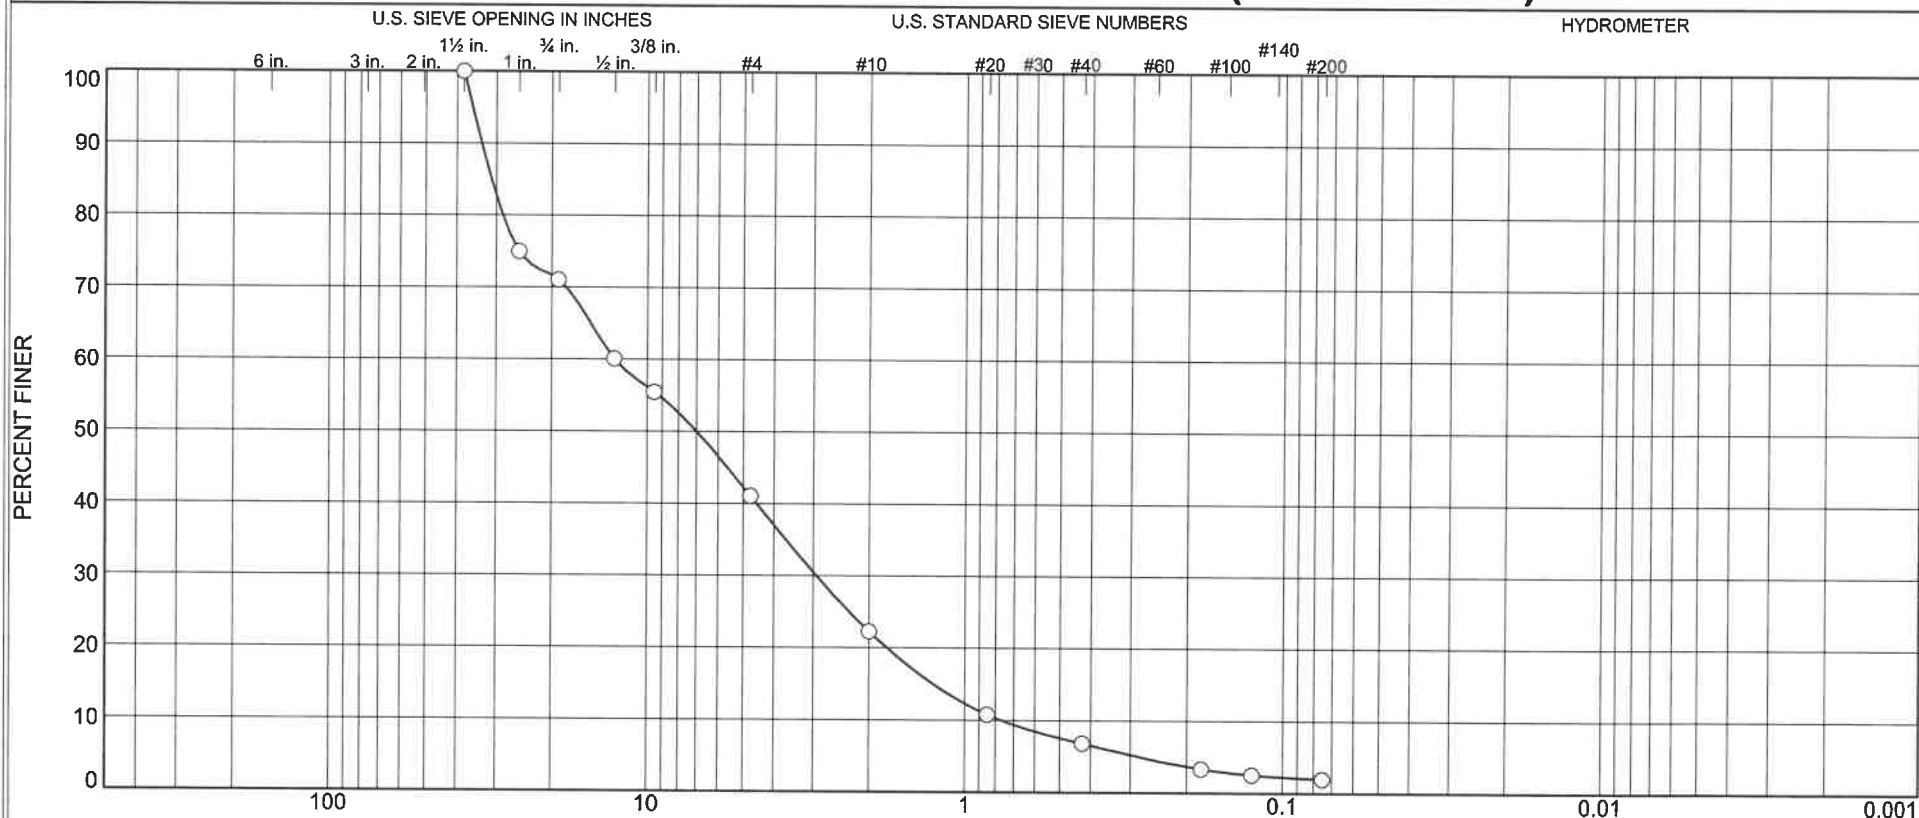
GRADATION AND CLASSIFICATION (ASTM D2487)

% +3"	% Gravel		% Sand			% Fines	
	Coarse	Fine	Coarse	Medium	Fine	Silt	Clay
0.0	29.0	29.9	18.8	15.5	4.8	2.0

Source	Sample #	Depth/Elev.	Date Sampled	USCS	Material Description	NM %	LL	PL
TP-I-4B	S-1	9.7'/897.0	8/4/23	GP	brown poorly graded GRAVEL with sand Stratum B	2.8	NV	NP

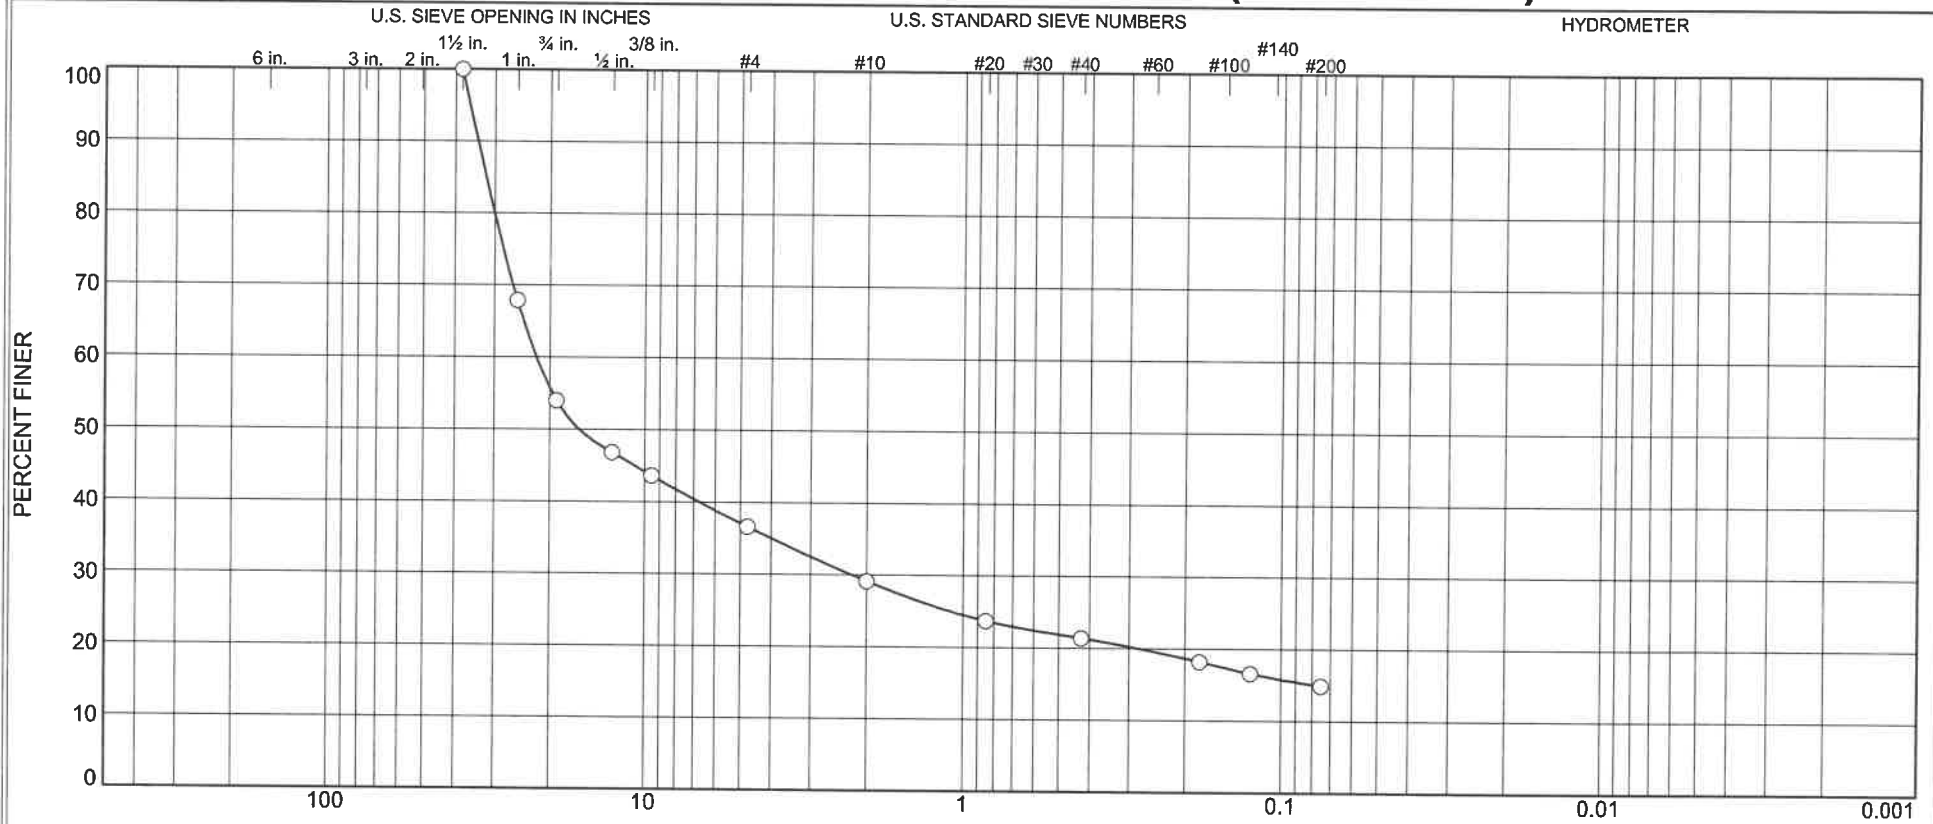
GRADATION AND CLASSIFICATION (ASTM D2487)

% +3"	% Gravel		% Sand			% Fines	
	Coarse	Fine	Coarse	Medium	Fine	Silt	Clay
0.0	46.0	17.4	7.5	7.7	6.5	14.9

Source	Sample #	Depth/Elev.	Date Sampled	USCS	Material Description	NM %	LL	PL
TP-I-5A	S-1	1.9'/894.0	8/4/23	GM	brown silty GRAVEL with sand Stratum B	6.3	NV	NP

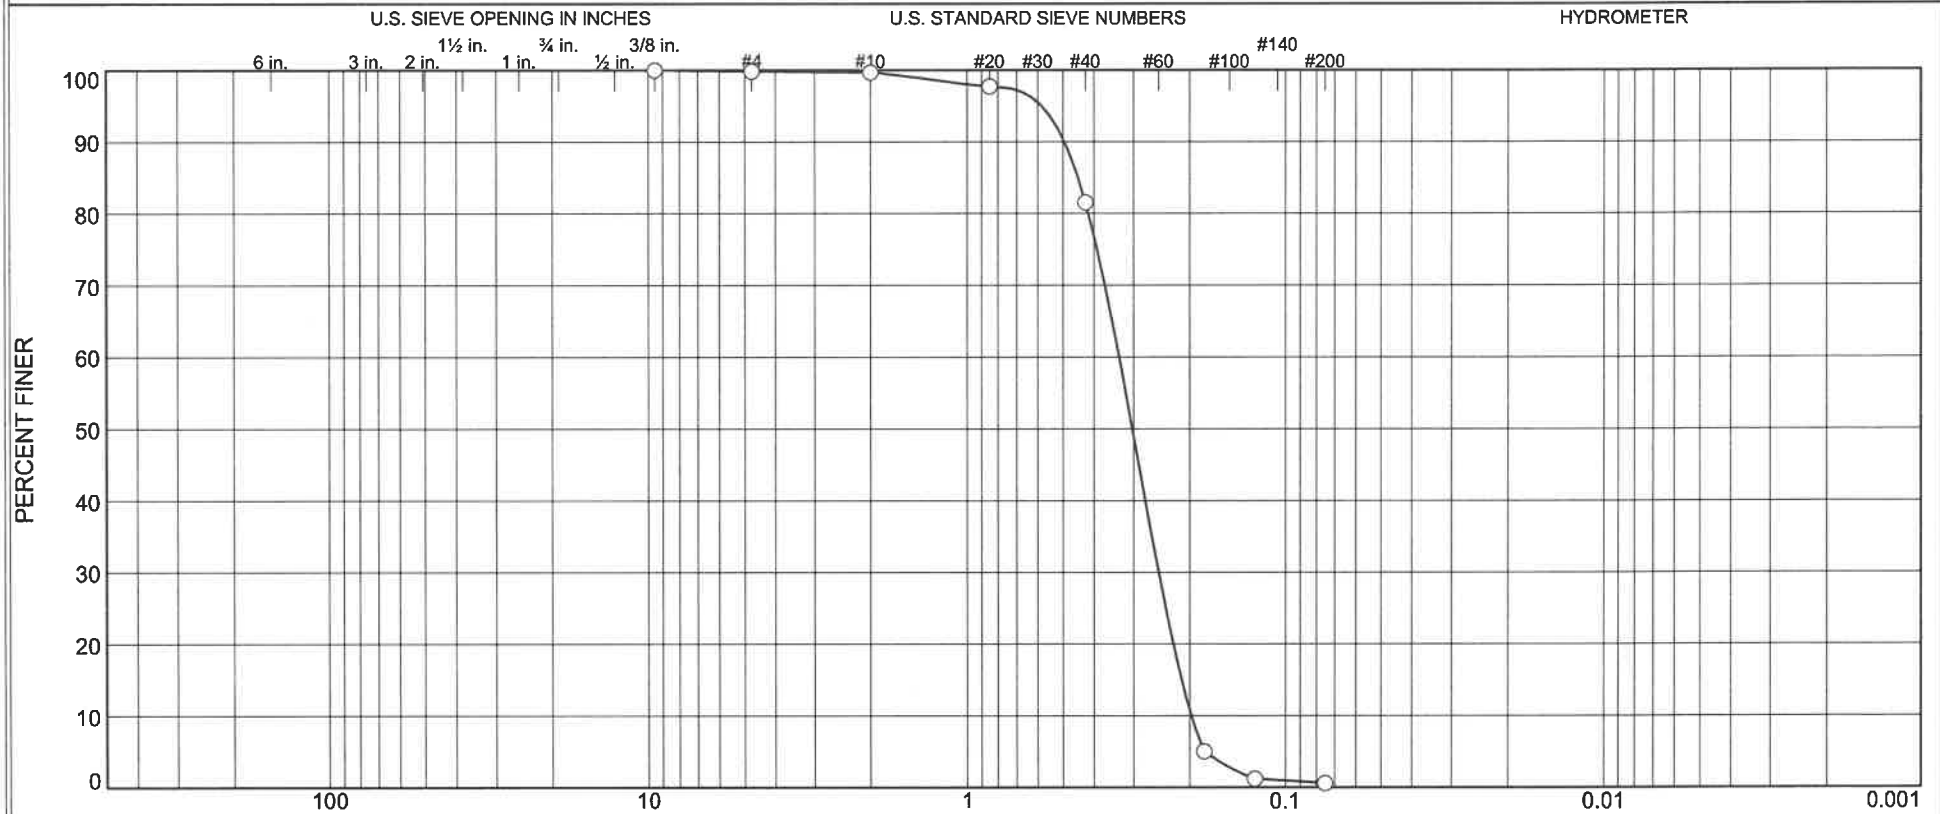
GRADATION AND CLASSIFICATION (ASTM D2487)

% +3"	% Gravel		% Sand			% Fines	
	Coarse	Fine	Coarse	Medium	Fine	Silt	Clay
0.0	0.0	0.2	0.1	18.2	80.9	0.6

Source	Sample #	Depth/Elev.	Date Sampled	USCS	Material Description	NM %	LL	PL
TP-I-6A	S-2	10.2'/890.0	8/4/23	SP	brown poorly graded SAND Stratum B	5.3	NV	NP

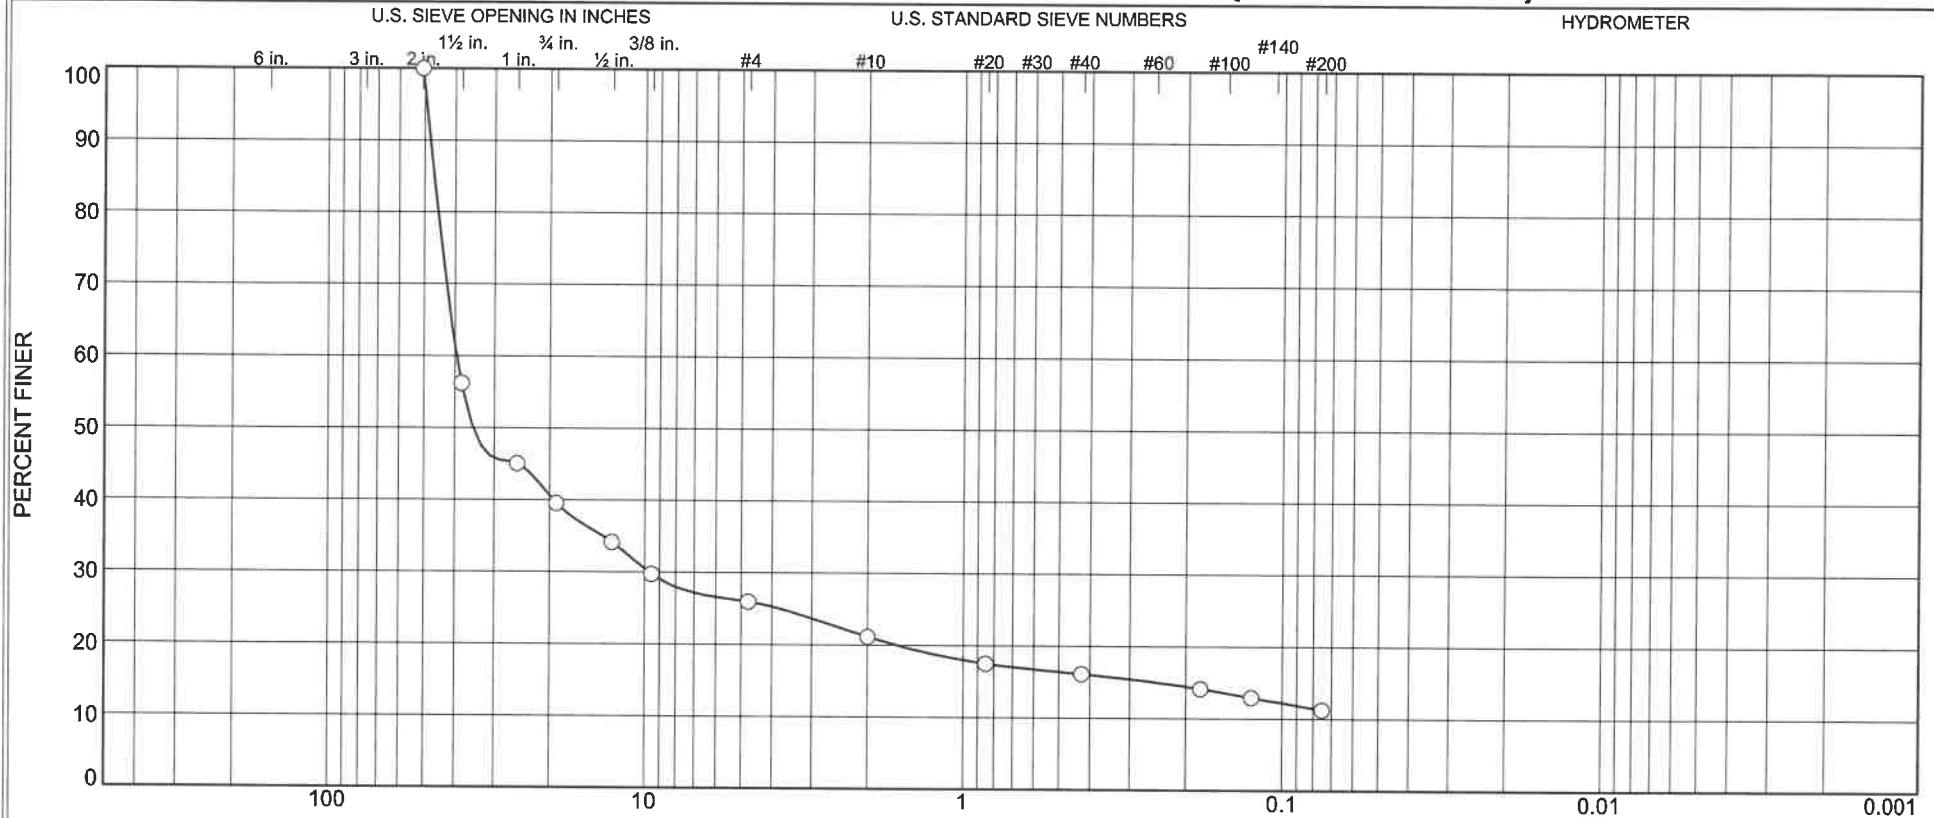
GRADATION AND CLASSIFICATION (ASTM D2487)

GRAIN SIZE - mm.

% +3"	% Gravel		% Sand			% Fines	
	Coarse	Fine	Coarse	Medium	Fine	Silt	Clay
0.0	60.5	13.5	4.8	5.1	4.9	11.2

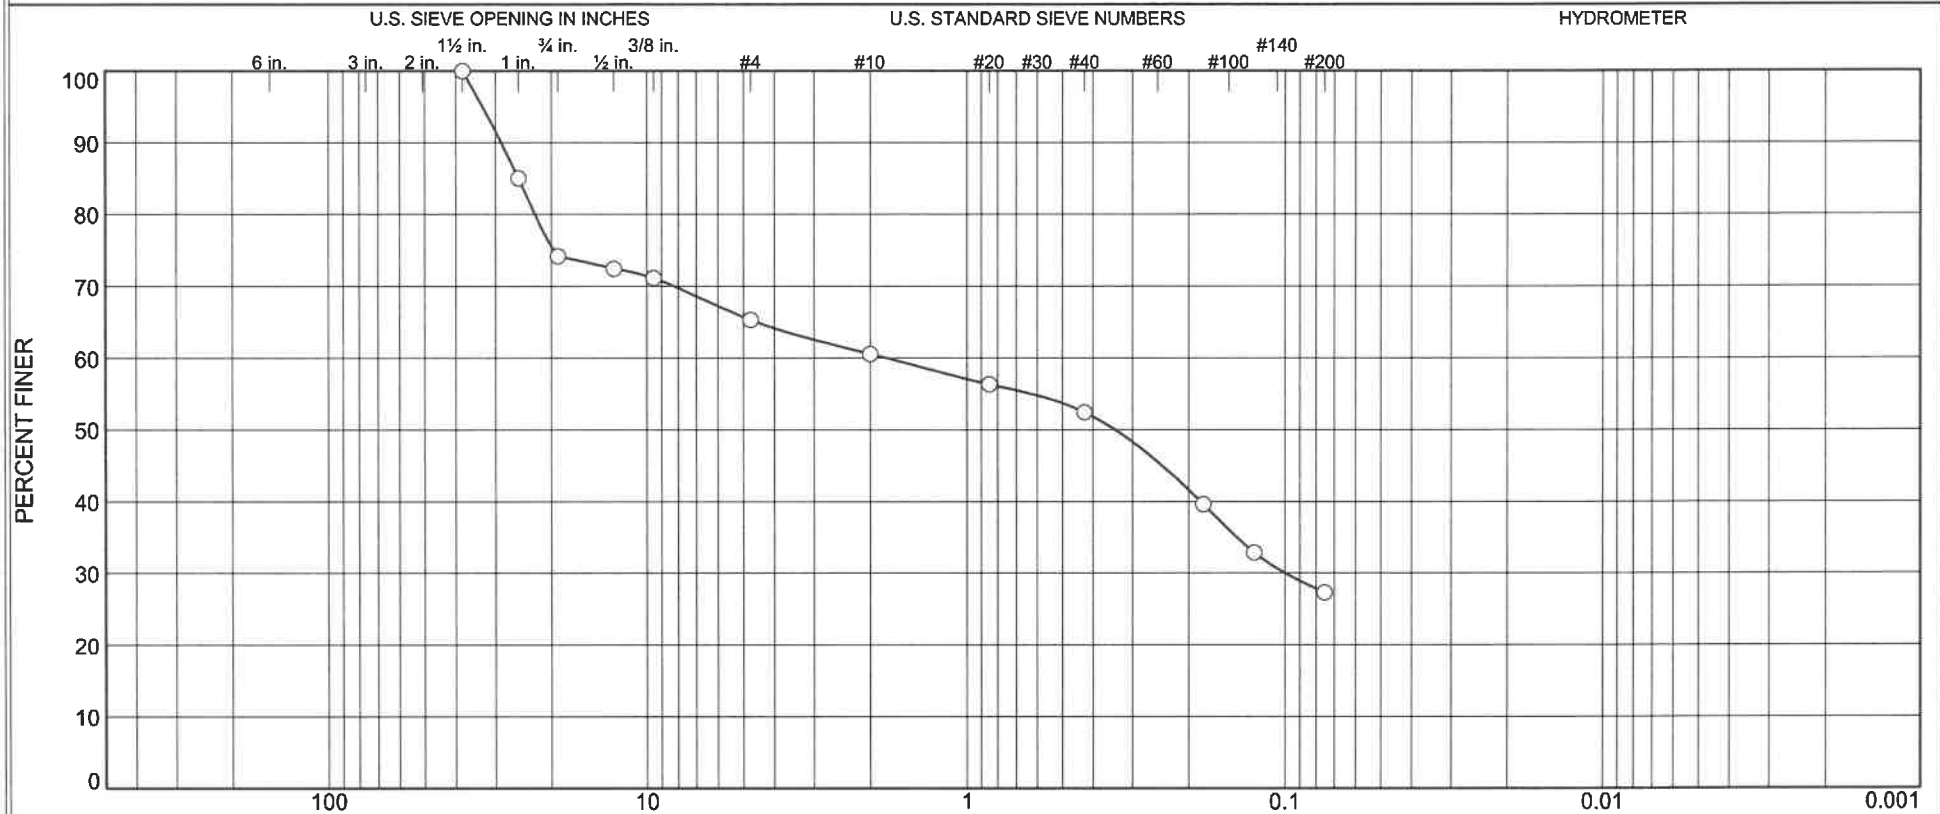
GRADATION AND CLASSIFICATION (ASTM D2487)

% +3"	% Gravel		% Sand			% Fines	
	Coarse	Fine	Coarse	Medium	Fine	Silt	Clay
0.0	25.8	8.9	4.7	8.2	25.1	27.3

Source	Sample #	Depth/Elev.	Date Sampled	USCS	Material Description	NM %	LL	PL
TP-I-6E	S-1	0.5'/888.0	8/4/23	SM	gray/brown silty SAND with gravel-FILL Stratum F	15.2	NV	NP

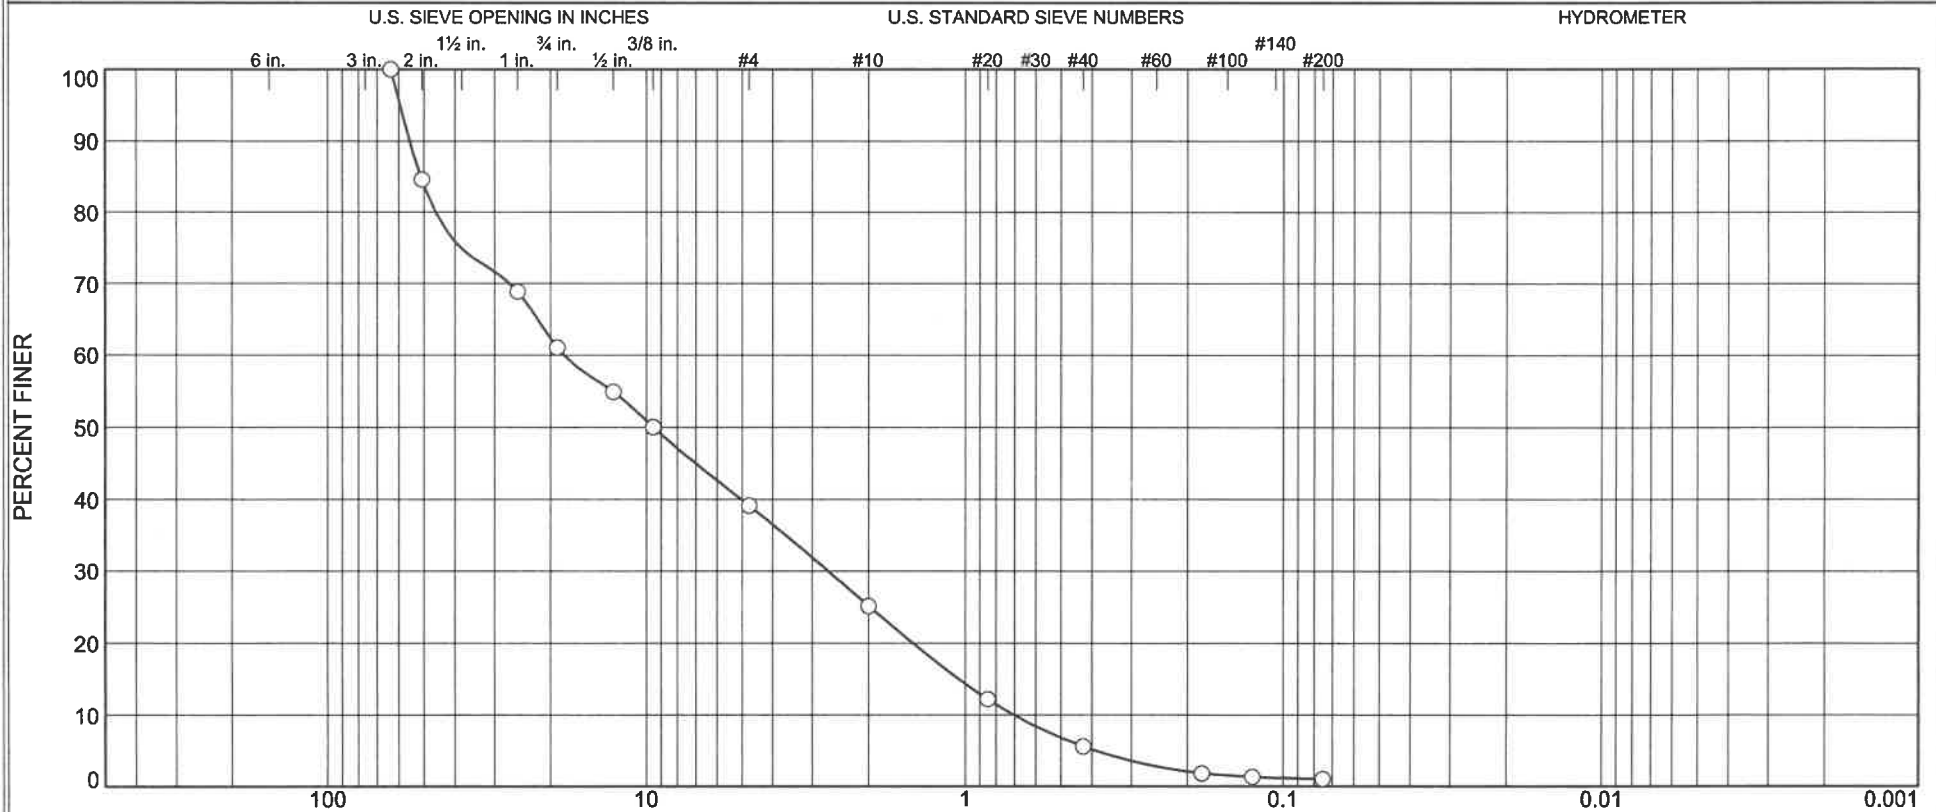
GRADATION AND CLASSIFICATION (ASTM D2487)

% +3"	% Gravel		% Sand			% Fines	
	Coarse	Fine	Coarse	Medium	Fine	Silt	Clay
0.0	38.9	22.0	13.9	19.6	4.6	1.0

Source	Sample #	Depth/Elev.	Date Sampled	USCS	Material Description	NM %	LL	PL
TP-15	S-1	4.0'/907.7	8/4/23	GP	brown poorly graded GRAVEL with sand Stratum B	2.6	NV	NP

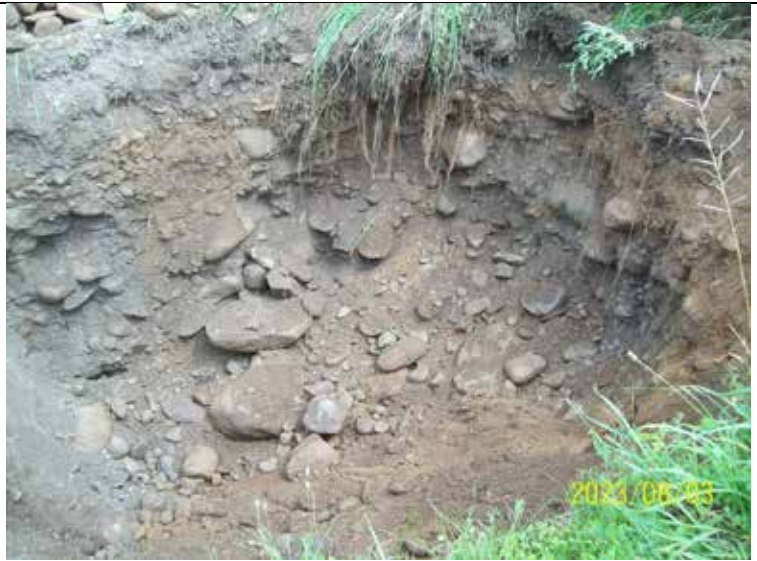
Depth (ft.)	Strata Description	Class.	Str'm	Elev.	InSitu Testing		M (%)	Remarks
					Depth	Geo. Pen.		
—	7" topsoil				—			
2 —	brown poorly graded GRAVEL with silt and sand, cobbles	GP- GM	B		2 —		9.4	
4 —					4 —		4.4	infiltration testing @ 4.8'; El 890.0
6 —					6 —			
				887.8				
8 —	Bottom of Test Pit at 7.0 feet				8 —			
10 —					10 —			
12 —					12 —			
14 —					14 —			
16 —					16 —			
18 —					18 —			
20 —					12 —

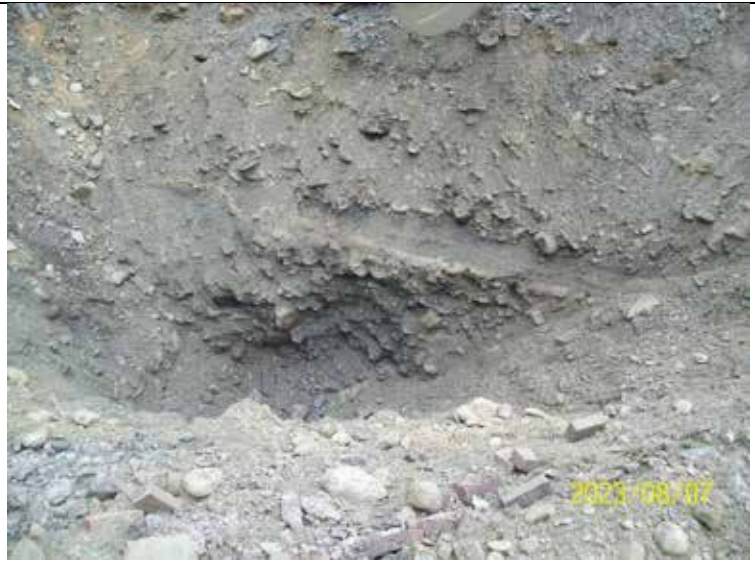
Depth (ft.)	Strata Description	Class.	Str'm	Elev.	InSitu Testing		M (%)	Remarks
					Depth	Geo. Pen.		
—	3" topsoil, brick, stone – FILL		F		—			
2				904.2	2			
—					—			
4	brown poorly graded GRAVEL with silt and sand	GP- GM	B		4			
—					—			
6					6			
—					—			
8					8		5.2	
—					—			
10					10			
—					—			
12	brown poorly graded GRAVEL with sand, occasional cobbles	GP			12			
—					—			
14					14			
—					—			
16					16		4.2	
—					—			
18					18			
—					—			
20	Bottom of Test Pit at 18.5 feet			887.7	12			infiltration testing @ 16.2'; El 890.0

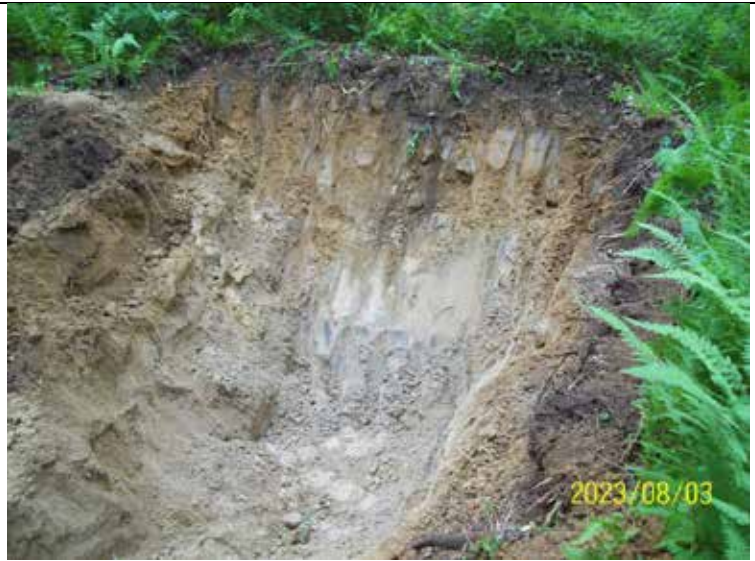
Depth (ft.)	Strata Description	Class.	Str'm	Elev.	InSitu Testing		M (%)	Remarks
					Depth	Geo. Pen.		
—	5" topsoil	SM	B	885.0	—		10.5	infiltration testing @ 0.5'; El 888.5
2 —	yellow, brown silty SAND with gravel				2 —			
—					—			
4 —	Bottom of Test Pit at 4.0 feet				4 —			
—					—			
6 —					6 —			
—					—			
8 —					8 —			
—					—			
10 —					10 —			
—					—			
12 —					12 —			
—					—			
14 —					14 —			
—					—			
16 —					16 —			
—					—			
18 —					18 —			
—					—			
20 —					12 —

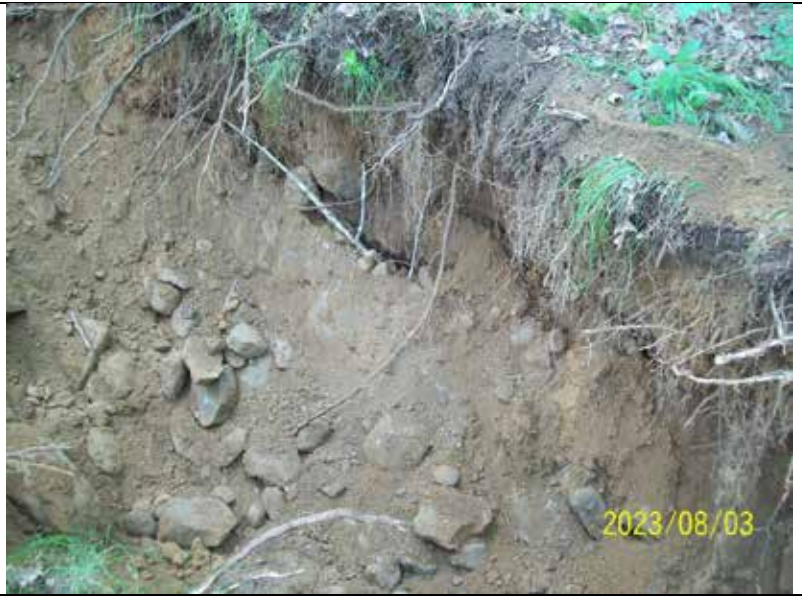
Depth (ft.)	Strata Description	Class.	Str'm	Elev.	InSitu Testing		M (%)	Remarks
					Depth	Geo. Pen.		
—	5" topsoil	SM	B	884.0	—		16.4	infiltration testing @ 0.5'; El 887.5
2	yellow, brown silty SAND with gravel				2			
4	Bottom of Test Pit at 4.0 feet				4			
6					6			
8					8			
10					10			
12					12			
14					14			
16					16			
18					18			
20					12

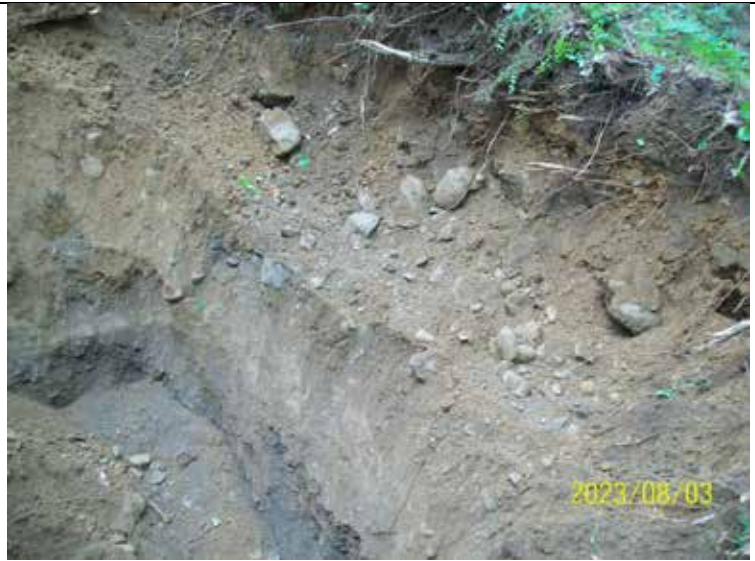
Depth (ft.)	Strata Description	Class.	Str'm	Elev.	InSitu Testing Depth	Geo. Pen.	M (%)	Remarks
—	3" topsoil				—			
2 —	brown poorly graded SAND with silt	SP-SM	B		2 —		12.6	
4 —	brown poorly graded GRAVEL with silt and sand, cobbles	GP-GM			4 —			
6 —	dark brown poorly graded SAND with silt and gravel	SP-SM			6 —		6.3 3.8	infiltration testing @ 4.8'; El 868.0
				865.8				
8 —	Bottom of Test Pit at 7.0 feet				8 —			
10 —					10 —			
12 —					12 —			
14 —					14 —			
16 —					16 —			
18 —					18 —			
20 —					20 —

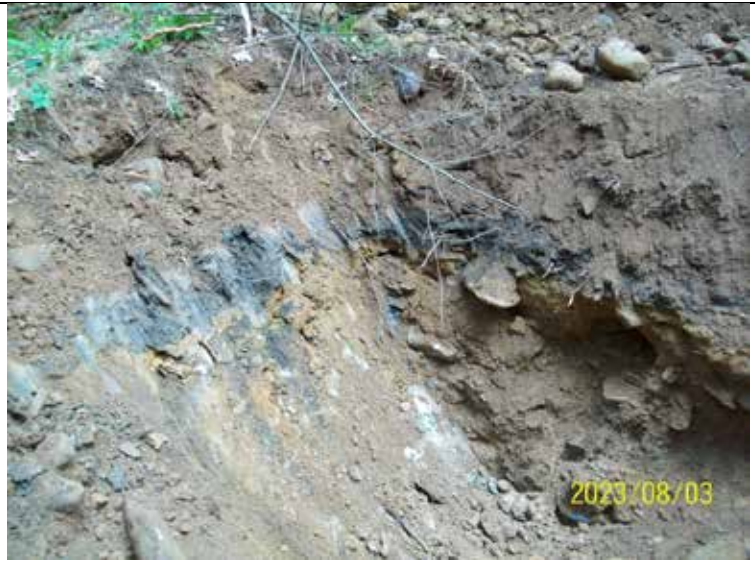
Depth (ft.)	Strata Description	Class.	Str'm	Elev.	InSitu Testing		M (%)	Remarks
					Depth	Geo. Pen.		
—	3" topsoil	SM	F	869.3	—		9.5	infiltration testing @ 3.3'; El 868.0
2	brown silty sand – FILL				2			
—	6" topsoil	GP	B	865.3	—			
4	brown poorly graded GRAVEL with sand, cobbles				4			
—	Bottom of Test Pit at 6.0 feet				6			
8					8			
—					—			
10					10			
—					—			
12					12			
—					—			
14					14			
—					—			
16					16			
—					—			
18					18			
—					—			
20					20

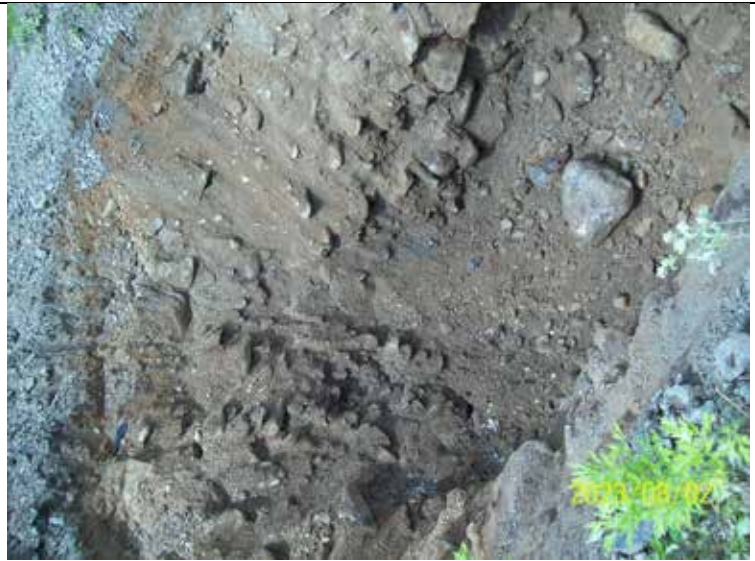
Depth (ft.)	Strata Description	Class.	Str'm	Elev.	InSitu Testing Depth	Geo. Pen.	M (%)	Remarks
—	2" topsoil gray poorly graded gravel with sand – FILL	GP	F	905.2	—			
2					2			
—	brown poorly graded SAND with gravel, cobbles	SP	B		—			
4					4			
—					—			
6					6			
—					—			
8					8			
—					—			
10					10		3.5	— infiltration testing @ 9.7'; El 897.0
—					—			
12	Bottom of Test Pit at 12.0 feet			894.7	12			
—					—			
14					14			
—					—			
16					16			
—					—			
18					18			
—					—			
20					20

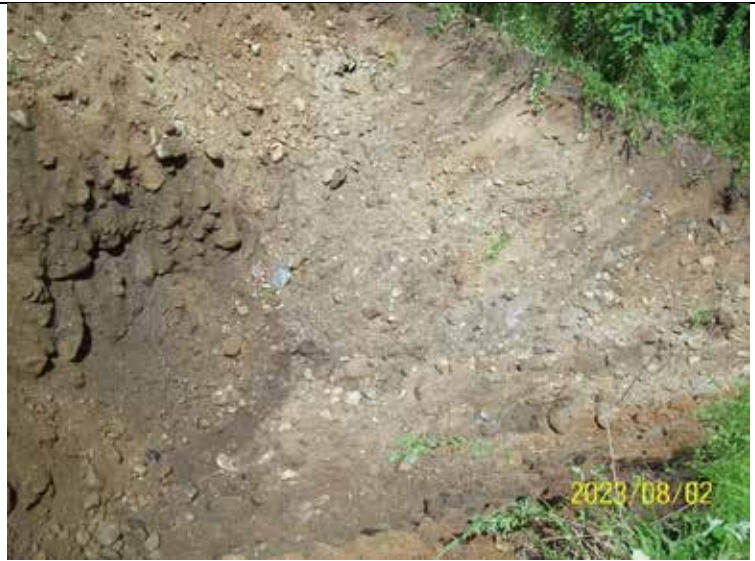
Depth (ft.)	Strata Description	Class.	Str'm	Elev.	InSitu Testing Depth	Geo. Pen.	M (%)	Remarks
—	6" topsoil				—			
2					2			
4	brown poorly graded GRAVEL with sand, cobbles	GP	B		4			
6					6			
8					8			
10					10		2.8	infiltration testing @ 9.7' El 897.0
12	Bottom of Test Pit at 12.0 feet			894.7	12			
14					14			
16					16			
18					18			
20					20

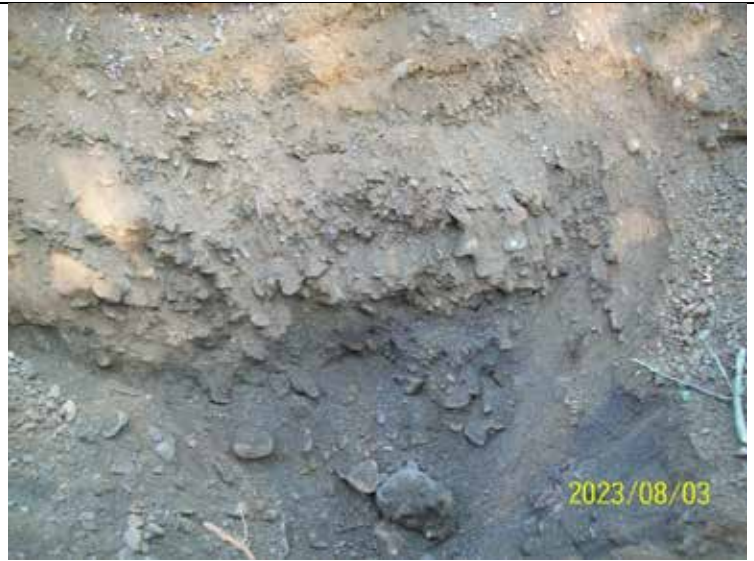
Depth (ft.)	Strata Description	Class.	Str'm	Elev.	InSitu Testing Depth	Geo. Pen.	M (%)	Remarks
—	4" topsoil				—			
2	orange, brown poorly graded SAND with silt and gravel	SP- SM	B		2		11.0	
4					4			
6	brown poorly graded GRAVEL with sand, cobbles	GP			6			
8					8		2.9	infiltration testing @ 7.4'; El 897.0
10	Bottom of Test Pit at 10.0 feet			894.4	10			
12					12			
14					14			
16					16			
18					18			
20					20

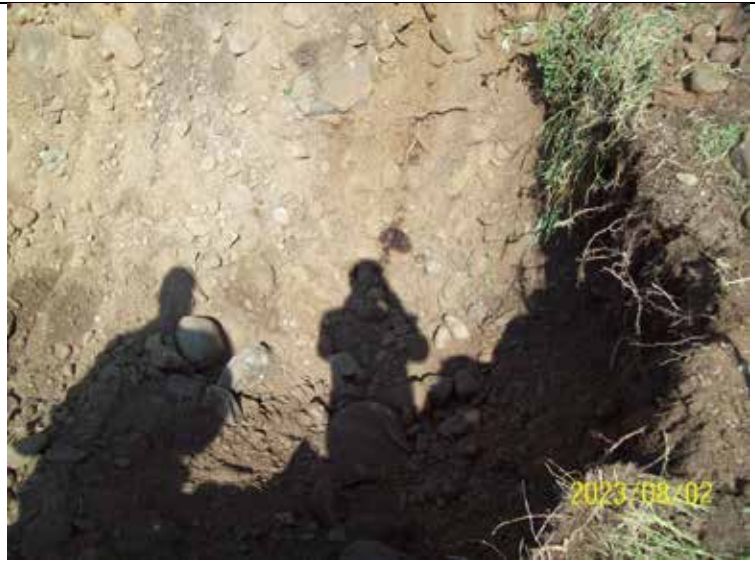
Depth (ft.)	Strata Description	Class.	Str'm	Elev.	InSitu Testing		M (%)	Remarks
					Depth	Geo. Pen.		
—	6" topsoil	GM	B	890.9	—		6.3	infiltration testing @ 1.9'; El 894.0
2	brown silty GRAVEL with sand				2			
—					—			
4					4			
—					—			
6	Bottom of Test Pit at 5.0 feet				6			
—					—			
8					8			
—					—			
10					10			
—					—			
12					12			
—					—			
14					14			
—					—			
16					16			
—					—			
18					18			
—					—			
20					20

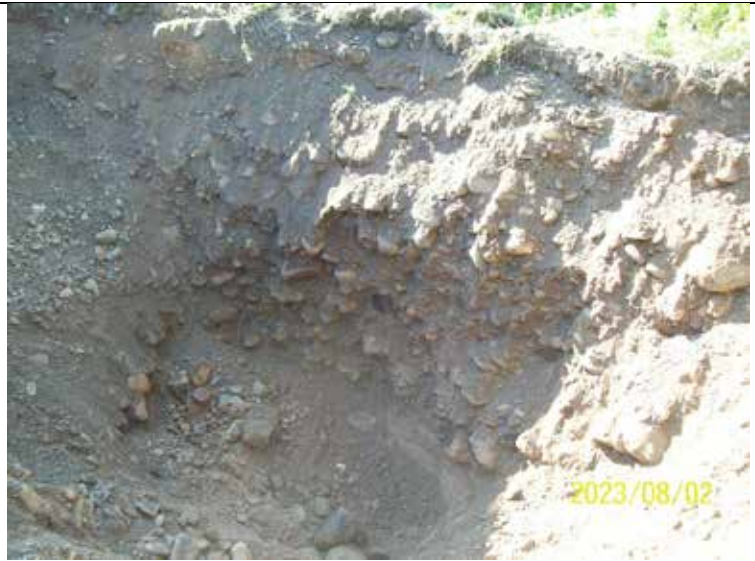
Depth (ft.)	Strata Description	Class.	Str'm	Elev.	InSitu Testing Depth	Geo. Pen.	M (%)	Remarks
—	3" topsoil	GP	B		—		3.7	
2	brown poorly graded GRAVEL with sand, cobbles				2			
—					—			
4					4			
—					—			
6		SP			6		5.3	infiltration testing @ 10.2'; El 890.0
—					—			
8					8			
—					—			
10	brown poorly graded SAND				10			
—				887.7	—			
12					12			
—					—			
14					14			
—					—			
16					16			
—					—			
18					18			
—					—			
20					20			
—					—

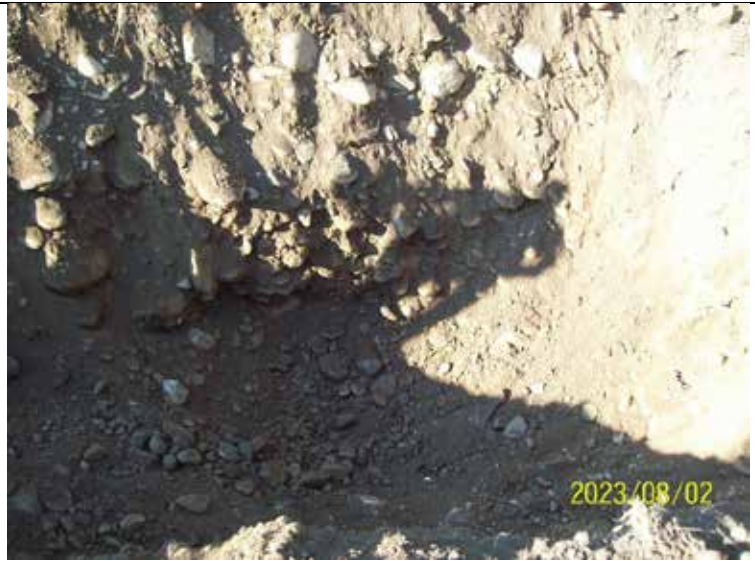
Depth (ft.)	Strata Description	Class.	Str'm	Elev.	InSitu Testing		M (%)	Remarks
					Depth	Geo. Pen.		
—	3" topsoil / gravel – FILL	GP	B	887.6	—		4.4	infiltration testing @ 10.1'; El 890.0
2	brown poorly graded GRAVEL with sand, cobbles				2			
—					—			
4					4			
—					—			
6					6			
—					—			
8					8			
—					—			
10					10			
—					—			
12	Bottom of Test Pit at 12.5 feet				12			
—					—			
14					14			
—					—			
16					16			
—					—			
18					18			
—					—			
20					20

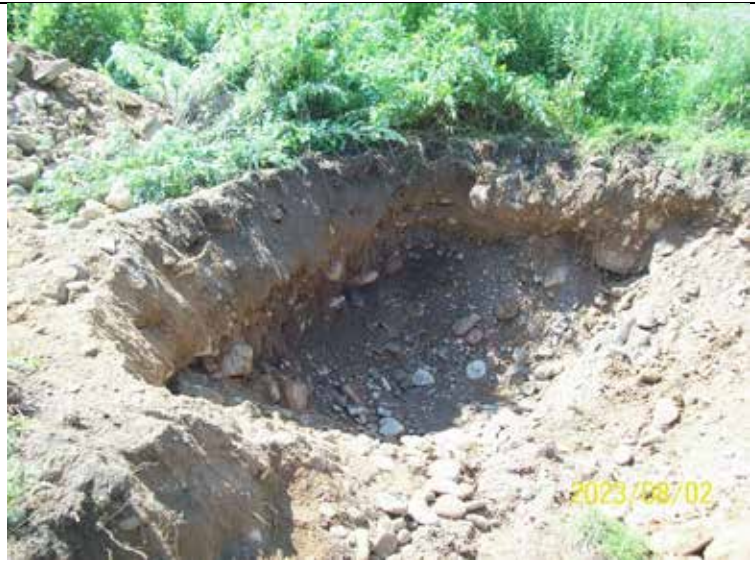
Depth (ft.)	Strata Description	Class.	Str'm	Elev.	InSitu Testing Depth	Geo. Pen.	M (%)	Remarks
—	5" topsoil				—			
2	brown poorly graded GRAVEL with silt	GP-GM	B		2		5.2	infiltration testing @ 1.5'; El 890.0
4	Bottom of Test Pit at 4.0 feet			887.5	4			
6					6			
8					8			
10					10			
12					12			
14					14			
16					16			
18					18			
20					20

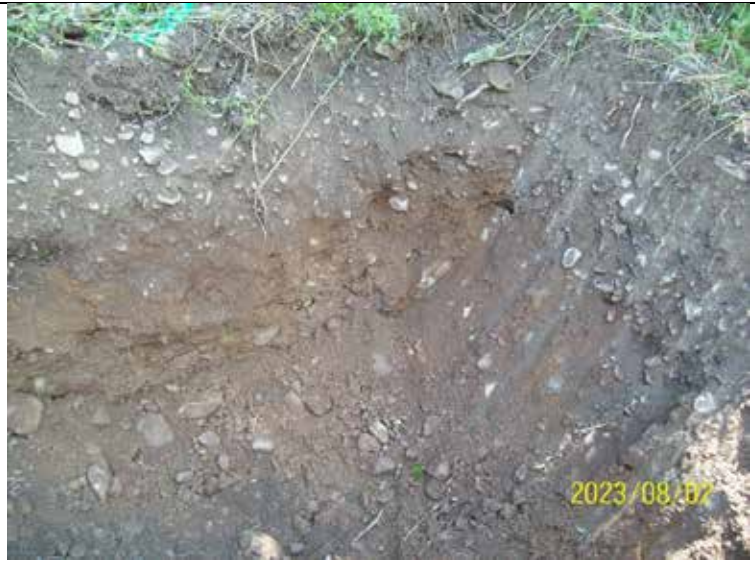
Depth (ft.)	Strata Description	Class.	Str'm	Elev.	InSitu Testing Depth	Geo. Pen.	M (%)	Remarks
—	5" topsoil				—		20.7	infiltration testing @ 0.5'; El 888.8
2	gray poorly graded GRAVEL with silt and sand	GP- GM	B		2			
—	brown, orange poorly graded SAND with gravel	SP			—			
4					4		14.3	
—				884.3	—			
6	Bottom of Test Pit at 5.0 feet				6			
—					—			
8					8			
—					—			
10					10			
—					—			
12					12			
—					—			
14					14			
—					—			
16					16			
—					—			
18					18			
—					—			
20					20
