GEOTECHNICAL ENGINEERING REPORT

STORMWATER MANAGEMENT AND INFILTRATION TESTING
MILFORD WAREHOUSE DEVELOPMENT
MILFORD TOWNSHIP, PA

(Project #23004-SWM)

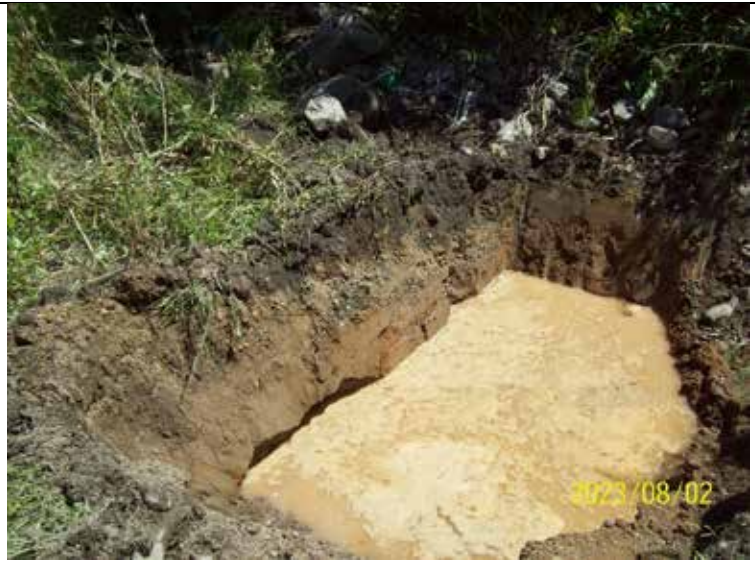
Depth (ft.)	Strata Description	Class.	Str'm	Elev.	InSitu Testing		M (%)	Remarks
					Depth	Geo. Pen.		
	5" topsoil gray, brown silty sand with gravel – FILL	SM	F	887.5			15.2	infiltration testing @ 0.5'; El 888.0
2	brown, gray silty SAND	SM	B		2		16.2	
4	Bottom of Test Pit at 4.0 feet			884.5	4			
6					6			
8					8			
10					10			
12					12			
14					14			
16					16			
18					18			
20					20

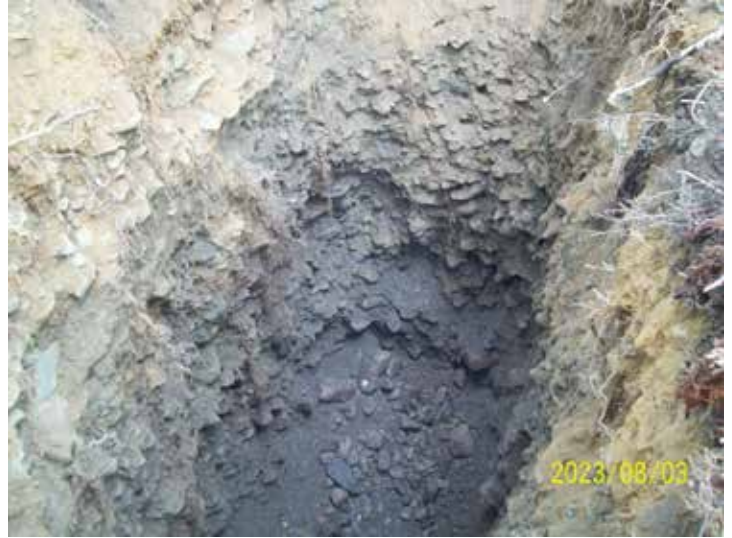
Depth (ft.)	Strata Description	Class.	Str'm	Elev.	InSitu Testing		M (%)	Remarks	
					Depth	Geoprobe Penetr'n			
1	6" topsoil	GP	B		1		2.6		
2	brown poorly graded GRAVEL with sand, cobbles				2				
3					3				
4					4				
5					5				
6					6				
7					7				
8					8				
9					9				
10					10		4.0		
11					11				
12					12				
13					13				
14					14				
15					15				
16					Bottom of Test Pit at 16.0 feet		16		
17		17

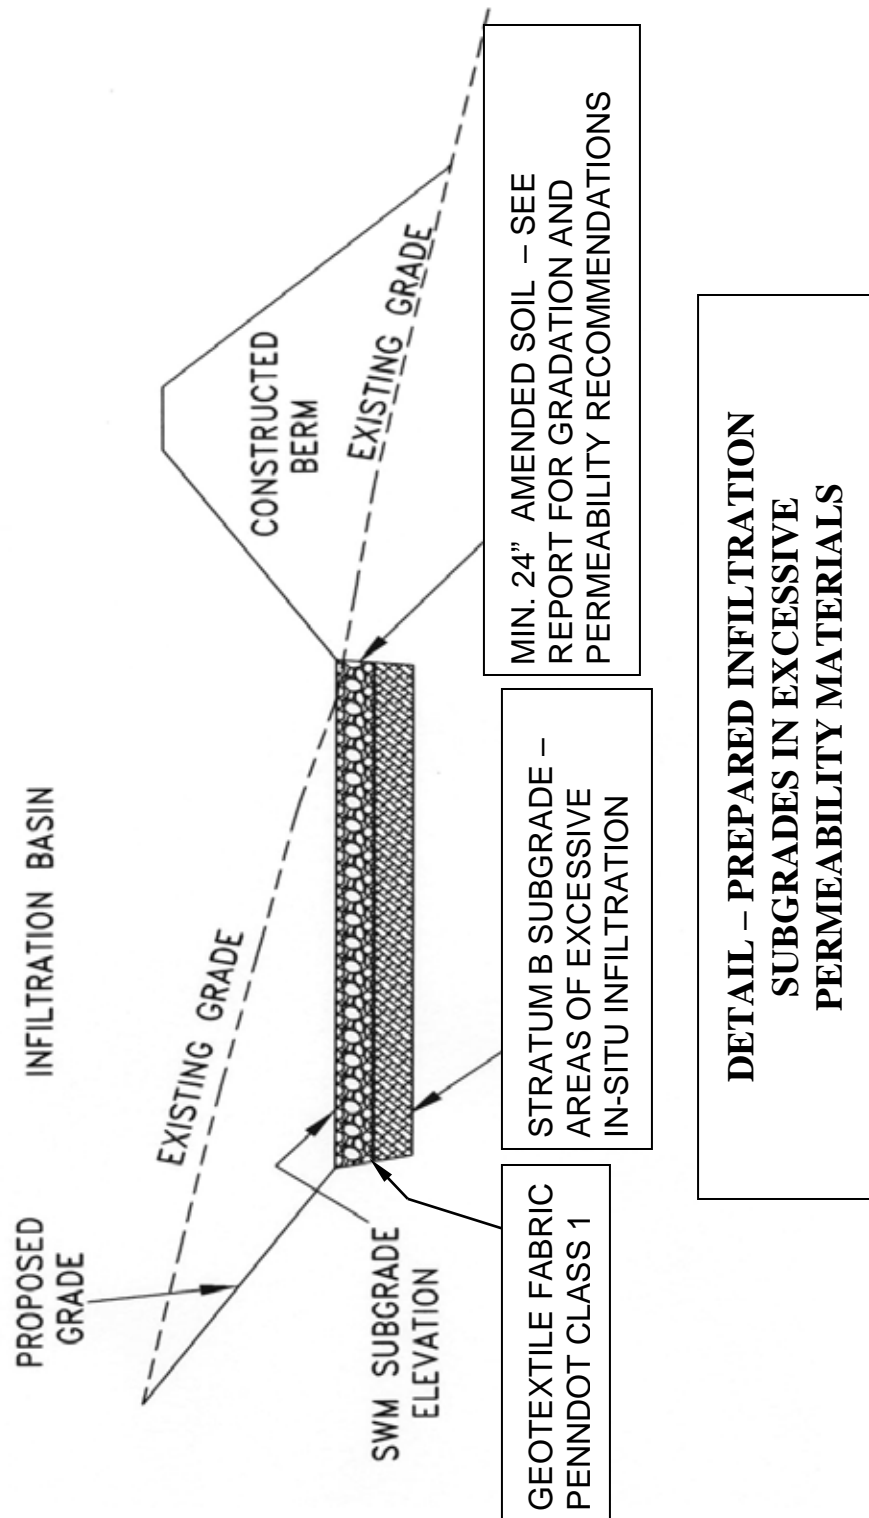
Drawing Title:
Detail - Prepared Infiltration Subgrades
Milford Warehouse Development
Milford Township, PA

An estimated proposed subgrade cross-section for this construction process is included for reference as Figure No. 6-1 in Enclosure (6). The soil buffer should be tested after installation to ensure the required infiltration rates are achieved.
